Salmons Brook Healthy River Challenge: The start-up performance of three constructed wetlands at improving water quality.

Water sampling, analysis and report by Dr. Nathalie Gilbert, Thames21. May 2016

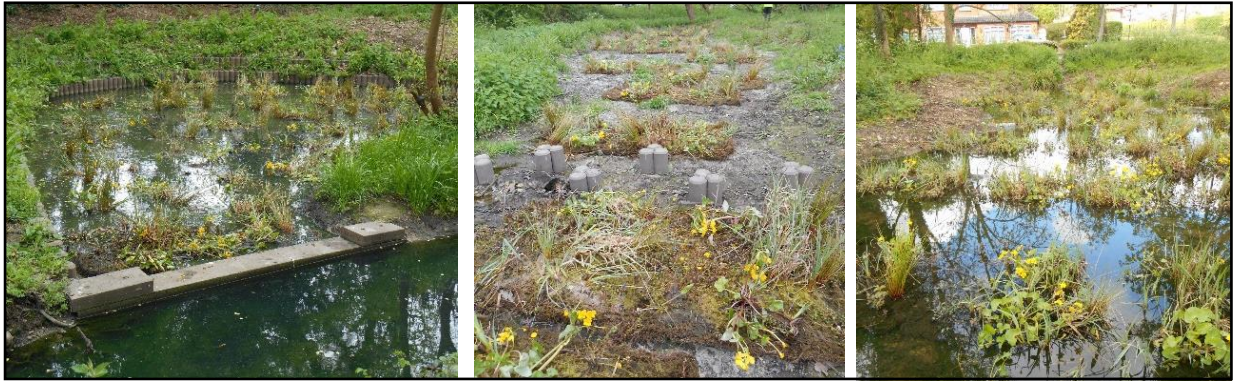
Figure 4: Left, basin 1 outflow weir with the Glenbrook in the foreground. Middle and Right, pre-planted coir pallets in position in basins 3 and 6 respectively.

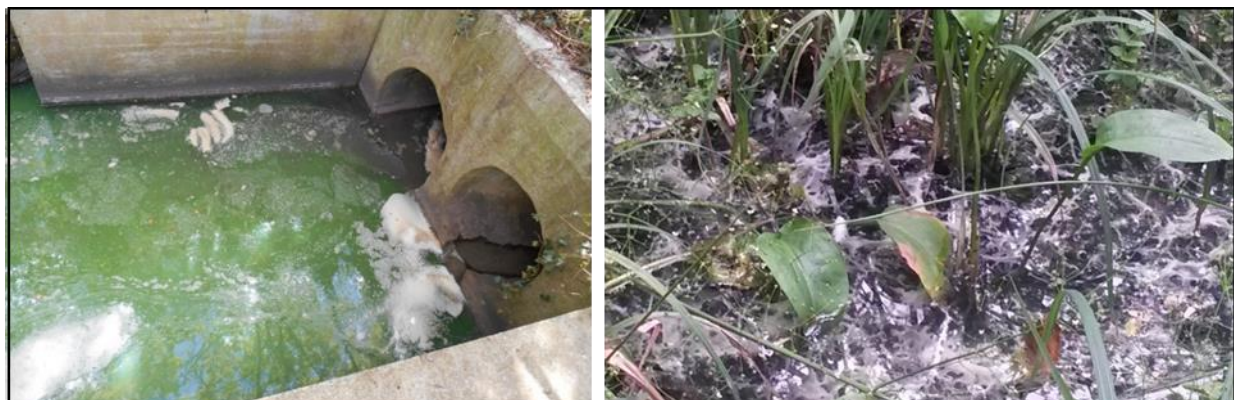
Figure 5: Left, the polluted Glenbrook where it becomes deculverted at the head of the constructed wetland basins. Right, sewage fungus in wetland basin 1.

The basins were initially planted with plug-plants, however these failed to establish due to disruption by unusually heavy winter rain events and heavy pollution from a large number of plumbing misconnections. Consequently, in late April 2015, the basins were replanted with pre-established coir pallets (Figure 4) planted with a native species mix appropriate for shallow water (Appendix A). The plants are expected to expand outwards and colonise the basins as they mature. Heavy pollution was apparent throughout the testing period, as evidenced by scum and odour at the inflow, and heavy

sewage fungus in the first treatment basins (Figure 5). Thames Water were carrying out investigations to resolve these issues.

Heavy contamination by domestic misconnections was evident in water sampled at the system inflow (pictured in Figure 5) through presence of high ammonia and total coliform bacteria counts, both indicative of raw sewage (Figures 15 and 16, Table 5). Ammoniacal-nitrogen at the system inflow was present in concentrations of up to 14.7 mg/L (Figure 15, Table 5, Appendix D), levels known to be harmful to aquatic life and which could potentially cause fish death if allowed to enter directly into Boxers Lake. In a study of 32 freshwater fish species, the mean acute (un-ionised) ammonia toxicity was 2.79 NH₃ mg/L (Saeger *et al* 1988), and <1.0 NH₃ mg/L for many benthic invertebrate species (Environment Agency/SNIFFER 2007). Low dissolved oxygen concentrations, frequently reported in outfalls contaminated by misconnections, are known to increase the effects of acute ammonia toxicity (Saeger *et al* 1988). The integrated wetland system serves the important function of detaining and slowing polluted water from entering Boxers Lake, thereby allowing the particularly toxic, un-ionised form of ammonia to undergo nitrification into other less harmful forms.

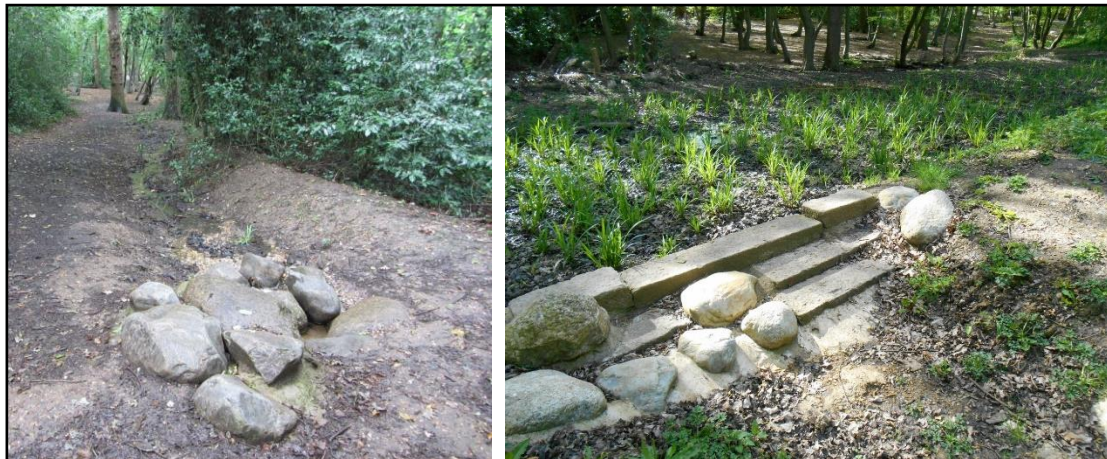
Figure 7: Left, the rocky outfall and swale diverting water from the Branscombe Gardens stormwater drain. Right, the infiltration basin, weir and outflow channel leading to the Grovelands Park Stream.
(Outfall image courtesy of Stefano Folini)

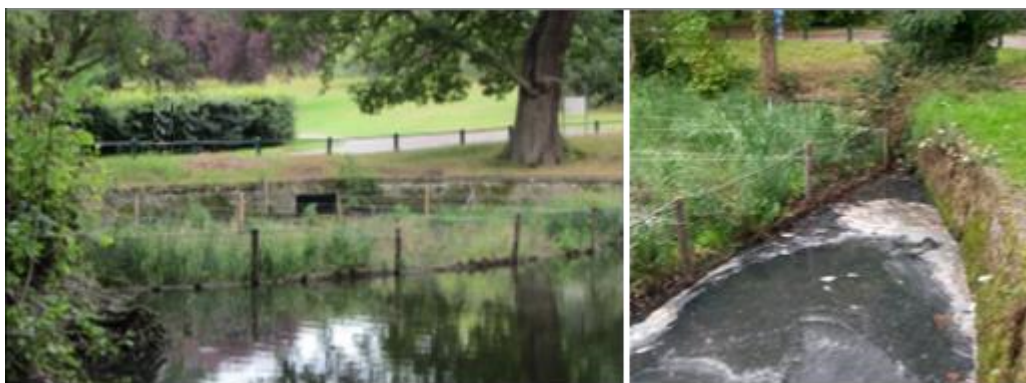
Figure 9: Left, the reedbed viewed looking south west. The outfall is visible as the rectangular opening in the wall behind the reedbed. Right, the reedbed viewed from the outfall. Note the visibly poorer water quality in the area in front of the reedbed, compared with immediately after it in the previous picture.

The difference in water quality above and below the reedbed is visually striking. The space before the reedbed is often turbid with a persistent surface scum, whereas the area immediately after the reedbed is noticeably cleaner (images, Figure 9).

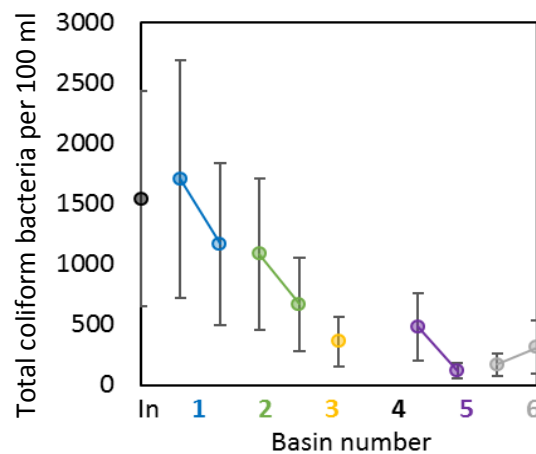
Figure 18: Mean (\pm se) concentrations of total coliform colonies in water sampled on 3 occasions at the main inflow (In) plus the inflows and outflows of each treatment basin of the integrated wetland, Glenbrook. Each basin (1-6) is represented by a different colour, the inflow and outflow linked by a line of the same colour. Basins 3 and 4 were off line. Water flow in the system from basin 1 through to basin 6.

Water was sampled at the inflow and outflow of each of the 6 treatment basins in the integrated wetland on 3 occasions, Figure 17 and 18. Indication from limited data is that the biggest improvements in nutrient parameters occurred primarily in basin 1, but also in basin 2. Water quality improved by smaller increments thereafter.

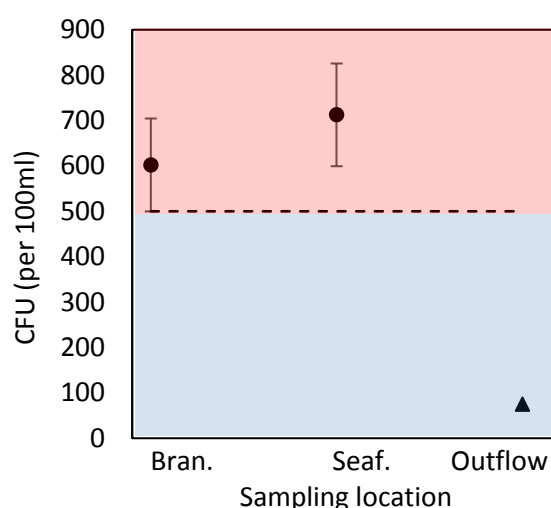
Figure 20: Mean (\pm s.e.) concentrations of total coliform bacteria colony forming units (CFU/100ml) from sampling locations in the infiltration basin, Grovelands Park. Sampling locations are: the inflow storm water drains from Branscombe Gardens and Seaforth Gardens and the infiltration basin outflow weir (sampled twice only) (see Figure 6, Table 2). Dashed lines represent threshold standards in water quality from the EU Bathing Water Directive, where ≤ 500 CFU/100ml is imperative (red) and ≥ 500 is guideline (blue).
