Craywatch:

River Cray Restoration Plan

Foots Cray Meadows

Date: 21/02/2020

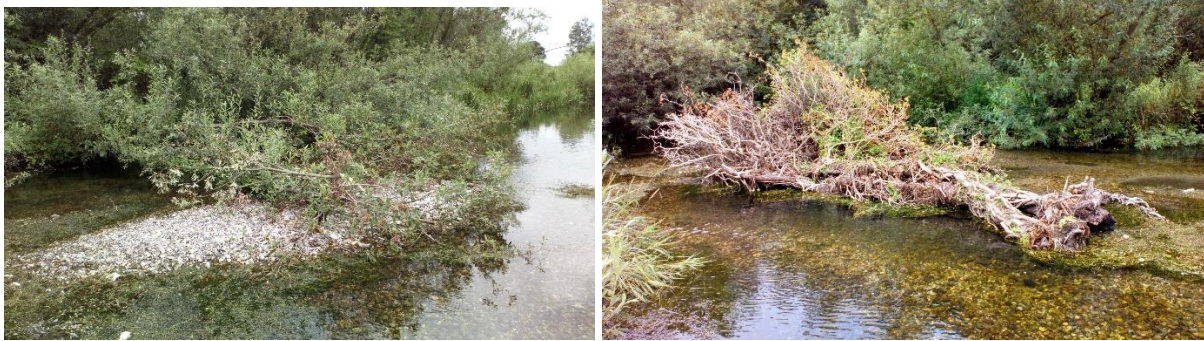
Figure 3, Photographs of geomorphic features upstream of Five Arches Bridge.

Geomorphic diversity is present in some areas, with upstream of Five Arches Bridge having clean gravels, in-channel berms and benches and large wood. Natural large wood in the river channel has successfully led to the formation of a mid-channel gravel bars, as shown in Figure 3. As the Cray moves downstream the channel bed becomes less diverse and is covered by a fine layer of silt, with no clean gravel pools or bars. Five Arches Bridge acts as a dam, impeding river flow and sediment

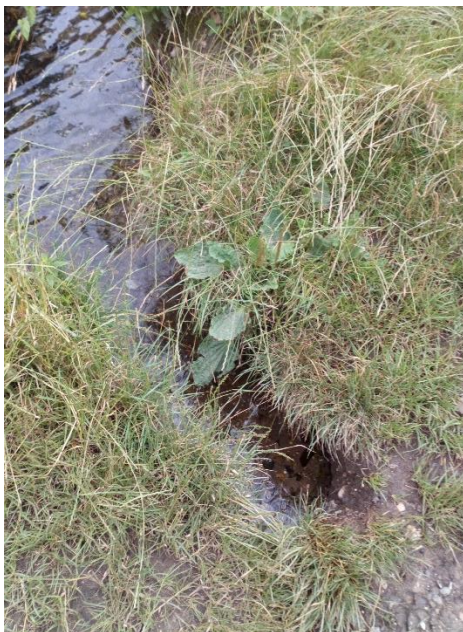
Figure 4, Evidence of poaching of the river banks.

transportation, contributing to the lack of diversity downstream. The River Cray has natural channel banks with surrounding bank top vegetation. While the channel banks are natural, they are heavily impacted by poaching as this is a heavily used public site for dog walkers. This has led to an increase in erosion in many areas of the channel banks, as shown in Figure 4. Previous river restoration to create vegetated channel bars have been only partially successful, as shown in Figure 5 and 6. This is likely due to a lack of sediment as the river is impounded by Five Arches Bridge and a lack of light due to extensive bank top trees.

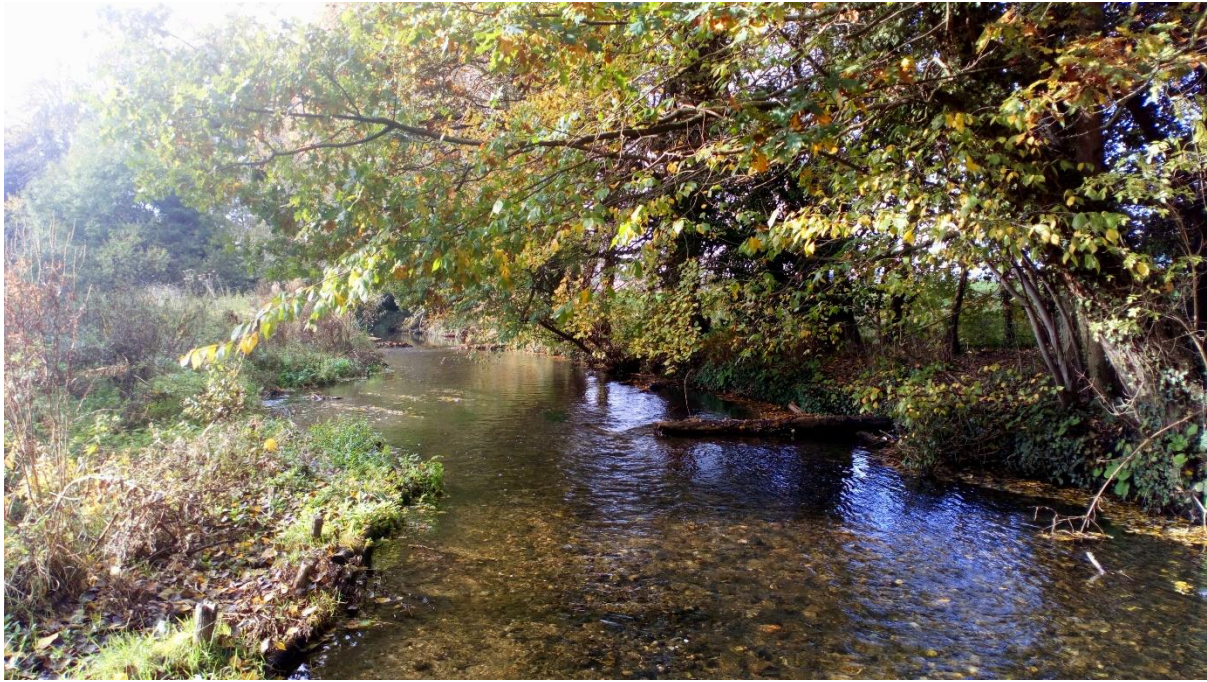
Figure 5, Photographs showing constructed berms as part of river restoration which have successfully vegetated.

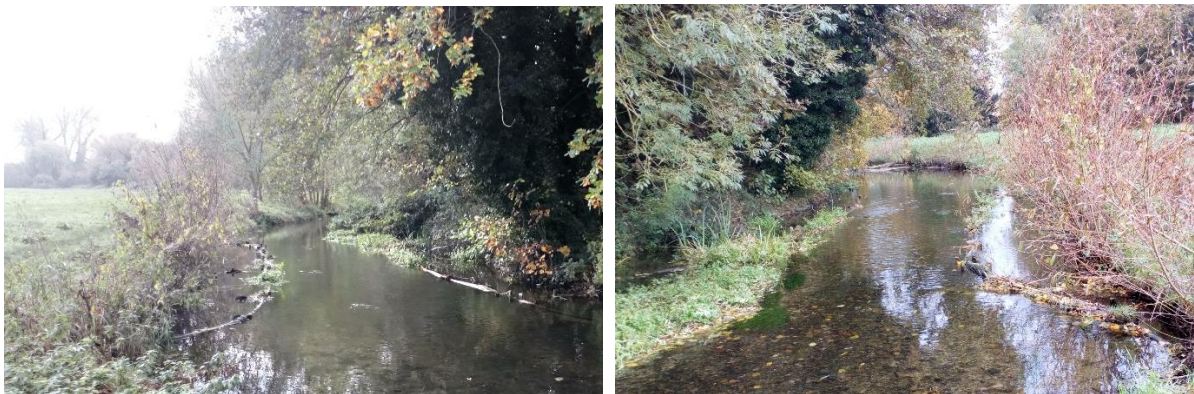
Figure 6, Photographs showing previous constructed berms as part of river restoration which have not fully vegetated.

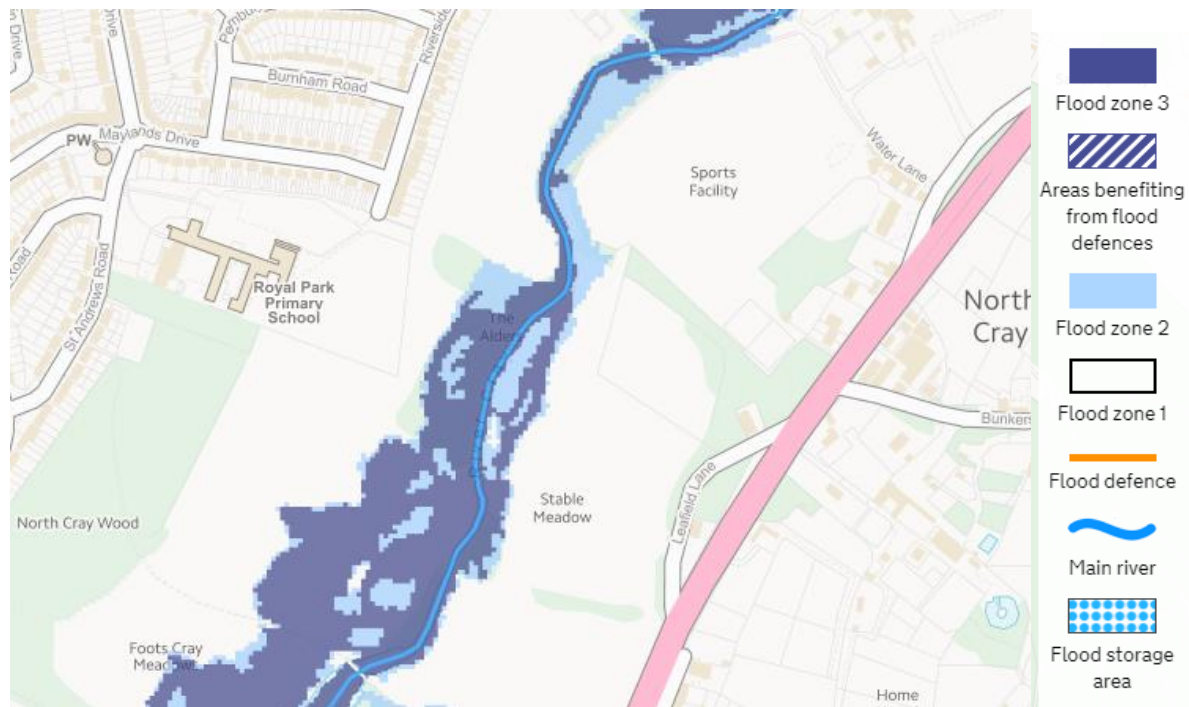
Figure 7, Environment Agency flood risk maps, showing the different flood zones of the River Cray in Footh Cray Meadows (Environment Agency. 2020).

The River Cray at Footh Cray Meadows does not present a flood risk to any commercial, public or residential dwelling, as shown in Figure 7. As the Cray flows through this open space it has a wide floodplain. There is therefore no concern that restoration interventions may increase flood risk.

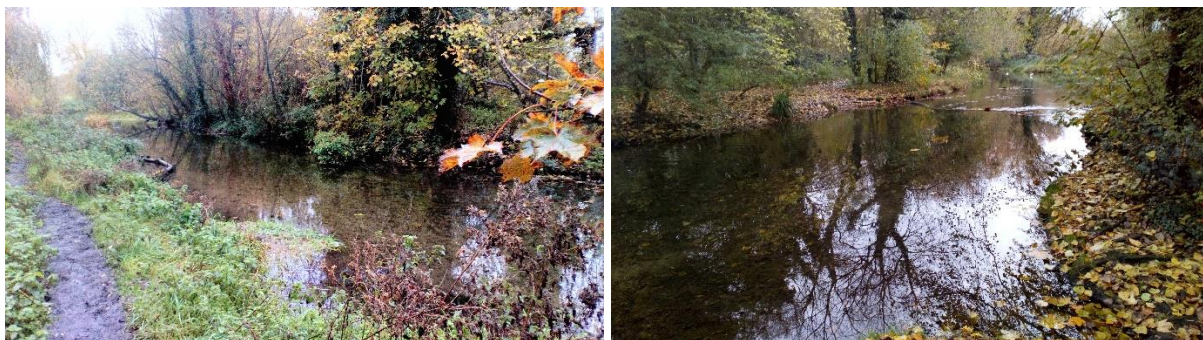
Figure 10, Photographs of Reach 1 showing an over-widened channel with little geomorphic diversity.

While much of this reach is over-widened with little geomorphic diversity, there are some stretches more geomorphic variation. For example downstream of Five Arches Bridge reedbed has developed naturally which pinches the River Cray. This creates faster flows and clean gravels.

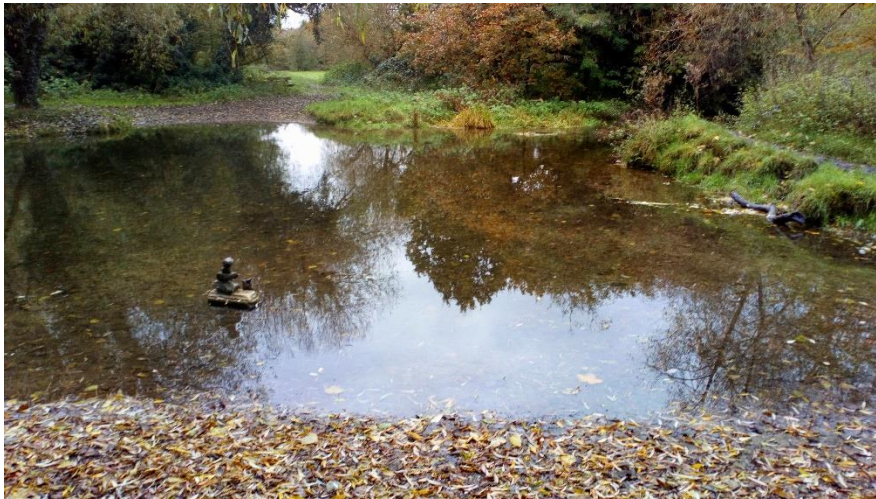
Figure 11, Showing ford in Reach 1, a popular recreation site for dogs and families.

There is a large ford in this reach with dog and public access to the river at both banks, as shown in Figure 11. In this area, in-channel wood will not be installed, allowing this section to continue to be used by members of the public and dogs.

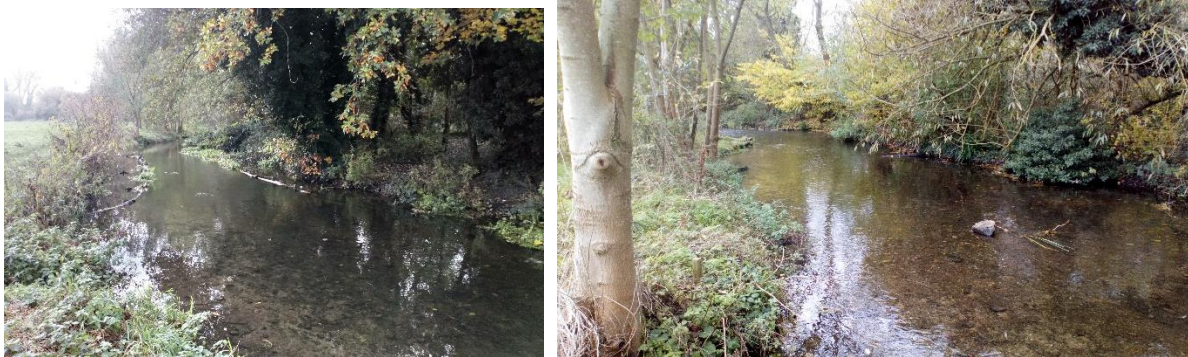
Figure 13, Photographs of Reach 2. These show unvegetated berms and tall bank top vegetation.

Public access to this reach is more limited, meaning the bank top is more densely vegetated. These bank top trees provide large amounts of shading in the summer, hindering the establishment of in-channel vegetation. As a result previous restoration interventions in this reach have been unable to fully vegetate.

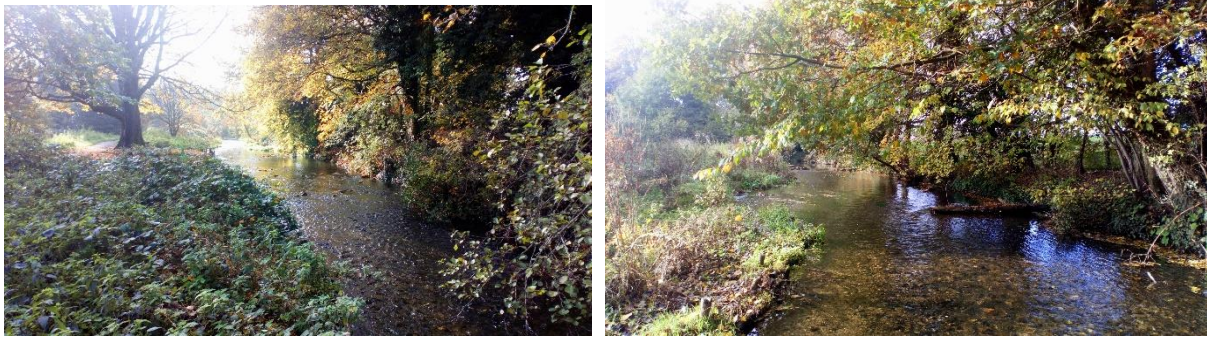
Figure 15, Photographs of Reach 3 showing little geomorphic diversity and tall bank top vegetation. Shows some previously installed berms in this reach to have successfully vegetated.

There is limited public access to this reach of the River Cray, it is therefore the least impacted by poaching. This reach has less tall bankside vegetation, allowing more light to reach the channel. This has allowed more in-channel vegetation to establish. There is evidence of bank erosion in this reach as shown in Figure 16.

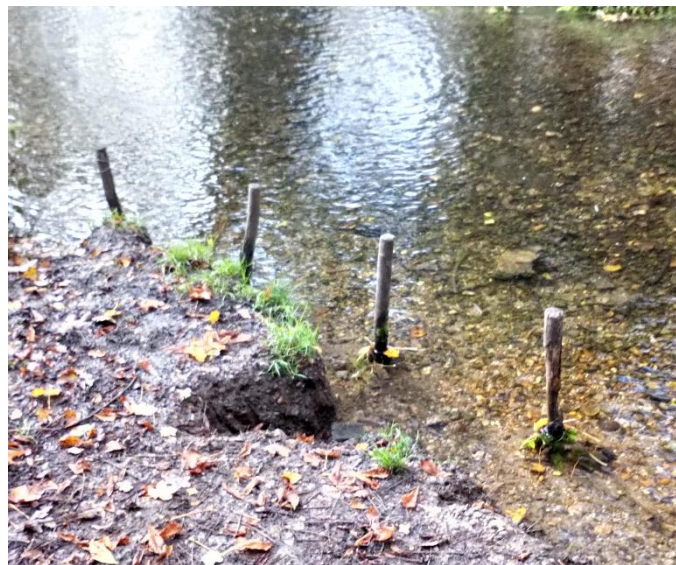
Figure 16, Evidence of bank erosion in Reach 3.

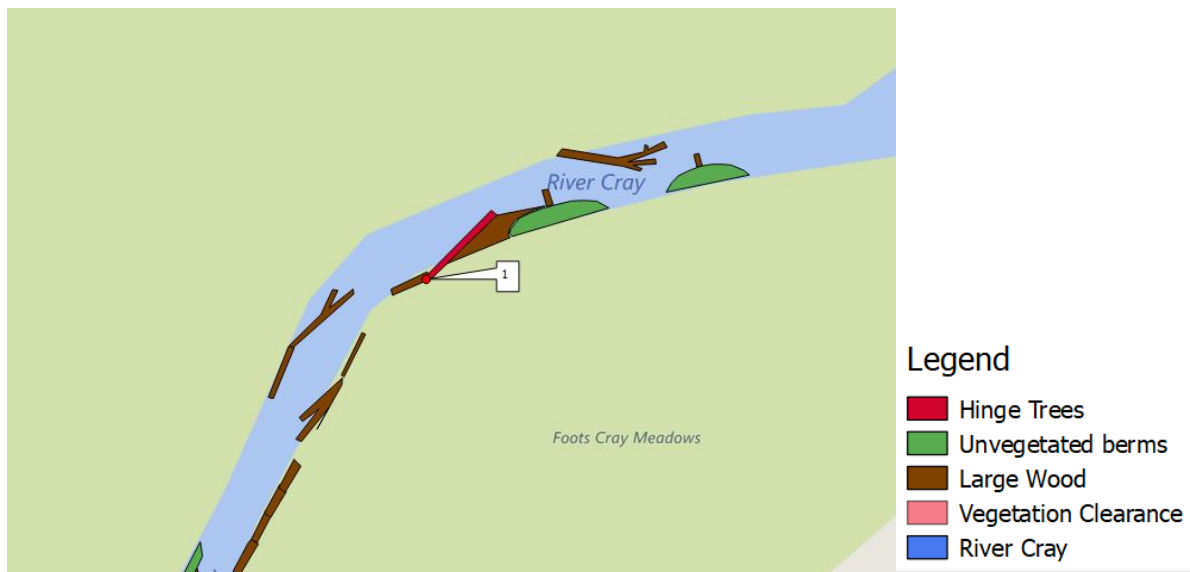
Figure 17, Map of restoration interventions in Reach 3.

Figure 17, shows restoration interventions that will be used in Reach 3. Fewer trees will be hinged due to the limited number of suitable bank top trees. Less bank top vegetation clearance is required in this reach due to fewer bank top trees. Evidence of some bank erosion is present, in this area large wood will be placed parallel to the channel bank to protect from further erosion. Berms that have been unable to vegetate will be filled with large wood and extended further out into the channel.
