Woodland and river management in two headwater streams, NFM Pilot: results and lessons

The Harrow headwaters NFM project is one of four Community Scale NFM pilots awarded £50,000 and delivered by Thames21 in partnership with the local council and community. This report discusses key results and lessons learned from the installation and monitoring of 29 leaky dams and 11 tree trunk dams in Bentley Priory and Stanmore Country Park, West London, by evaluating NFM effectiveness and the process of partnership working. Evaluation of the dams comprised hydrological modelling, water level sensors and volunteer reports and photographs, including development of an app. Wider benefits of the NFM were assessed by geomorphological surveys (MoRPh) and ecology surveys.

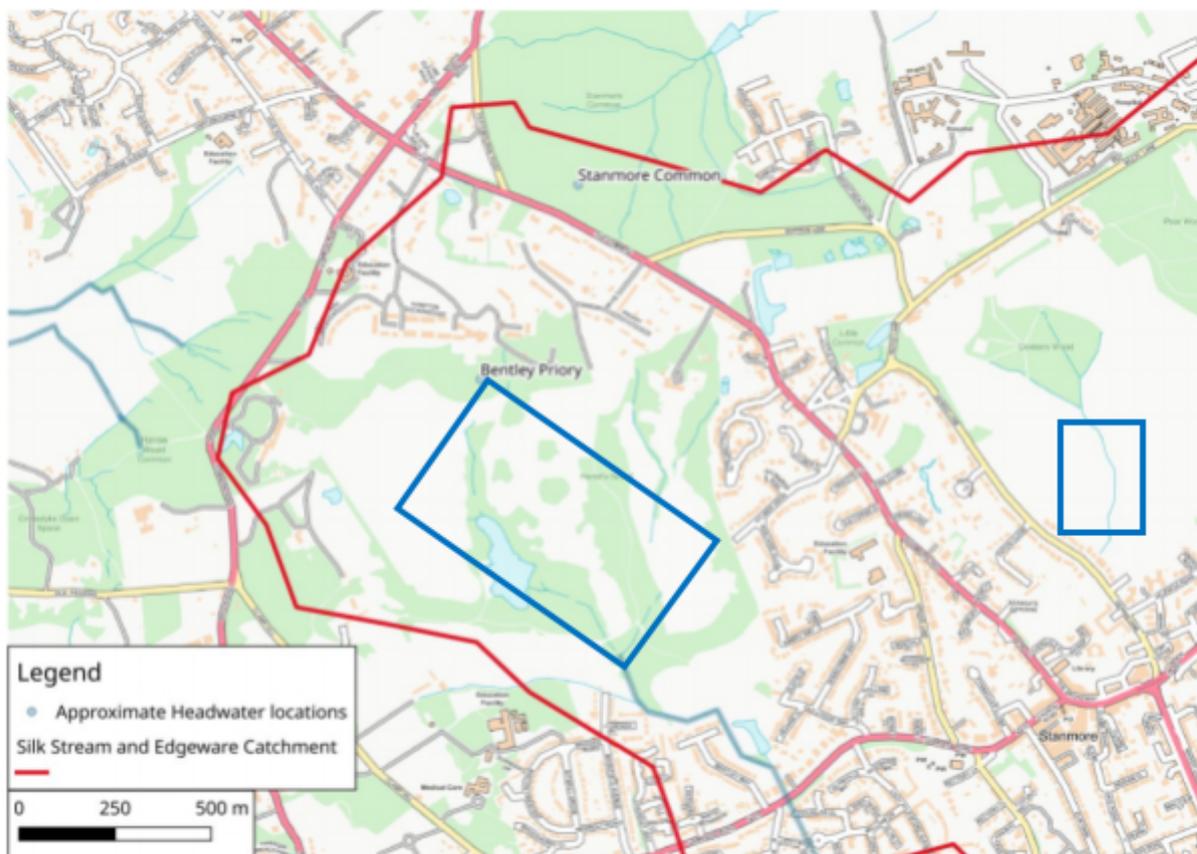
Figure 1: The Edgware Brook and Silk Stream catchments indicating in blue the areas where leaky dams were installed.

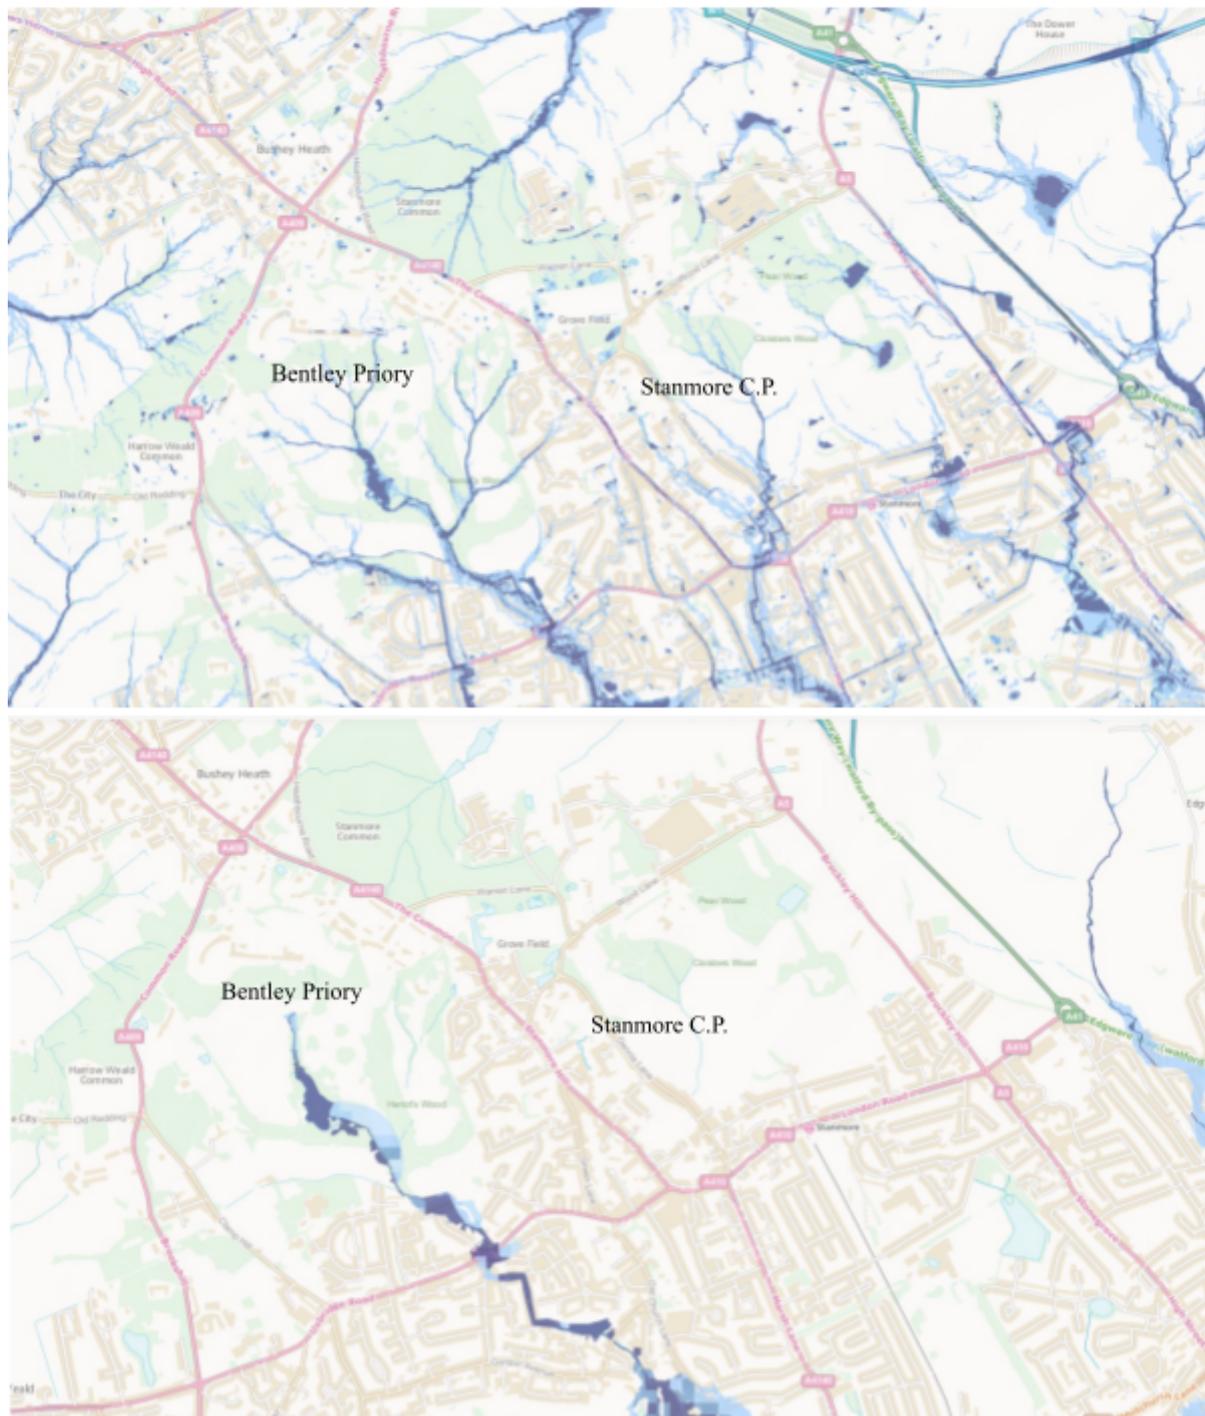
Figure 2: Environment Agency Risk of Flooding from Surface Water Maps showing fluvial (top) and pluvial (bottom) flood risk for the Edgware Brook and Silk Stream headwaters of the River Brent in a 1:100 year event. © Crown copyright 2013

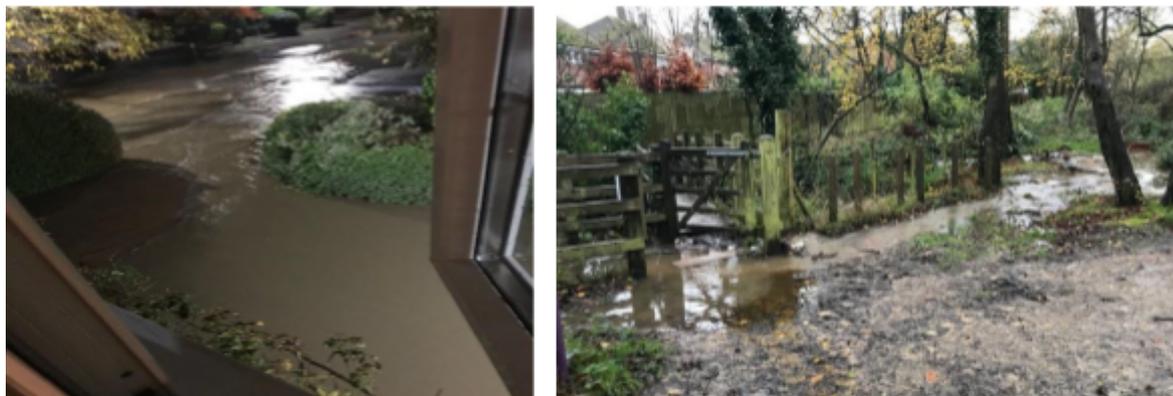
Figure 3: Flooding on 24th October 2020 after heavy rain, taken by a volunteer

invaluable to monitoring the effectiveness of the NFM installations and understanding flow dynamics within the wood - for example Figure 3.

The model was validated against out of bank extents from a minor flood event that occurred in October 2020 (images Figure 3, data Figures 24 and 25) and infiltration parameters adjusted to match. The model was truncated below Bentley Priory and Stanmore C.P. in

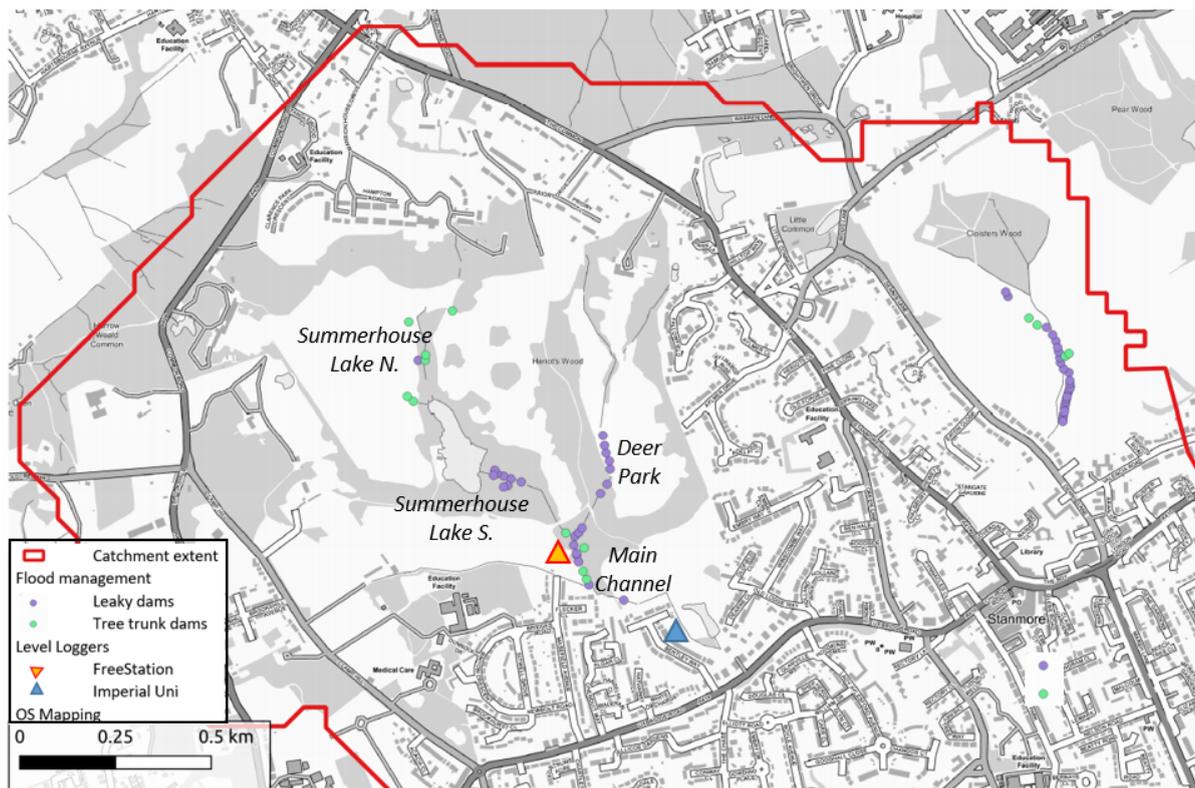
Figure 4: Locations of leaky barrier and tree trunk dams constructed in Bentley Priory and Stanmore Country Park; and water level monitoring devices (a FreeStation and a trial level sensor from Imperial University). Channels were named to aid identification.

Suitable sites (Figure 4) for installation of leaky dams and 10 tree trunk dams on the Edgware Brook in Bentley Priory (16 leaky dams, 10 tree trunk dams) and the Silk Stream in Stanmore Country Park (13 leaky dams, 1 tree trunk dam), plus proposed locations for further dams were identified through consultation/catchment walkovers in conjunction with Harrow Council and guided by ecology survey results of Bentley Priory SSSI. Following guidance from the Working with Natural Processes; Evidence Directory, dams were initially proposed in sets of 5. Following the site visits, some proposed locations were deemed not suitable due to channel characteristics and bankside flora restricting access. It was considered and to relocate these would result in dams being very close together that could reduce effectiveness and appear less aesthetically pleasing. It was initially the intention to use the flood modelling to guide the location of dams, however, due to time constraints, modelling of dams and other NFM features could only be undertaken retrospectively but will be used to inform future interventions.

The locations of 50 leaky dams and 11 tree trunk dams (built and proposed, Figure 4) were passed to Edenvale Young along with photographs and ‘as built’ dimensions corresponding to those uploaded to the AGOL portal. Built information (height above bank, orifice height and width, ‘leakiness’ based on photographs) was used to approximate layered flow constriction values. Due to grid size, each dam was represented as 10 m wide. Leaky barriers not yet built were set to 0.3 m above bank top with an assumed blockage of 90% and a form loss coefficient of 1.8. Dams were represented by changing the Manning's roughness.

The characteristics of the 12 leaky dams and 10 tree trunk dams in Bentley Priory and 13 leaky dams in Stanmore C.P. (Figure 4), are summarised in Table 3 and reported in full via the DEFRA pilot reporting portal (AGOL).

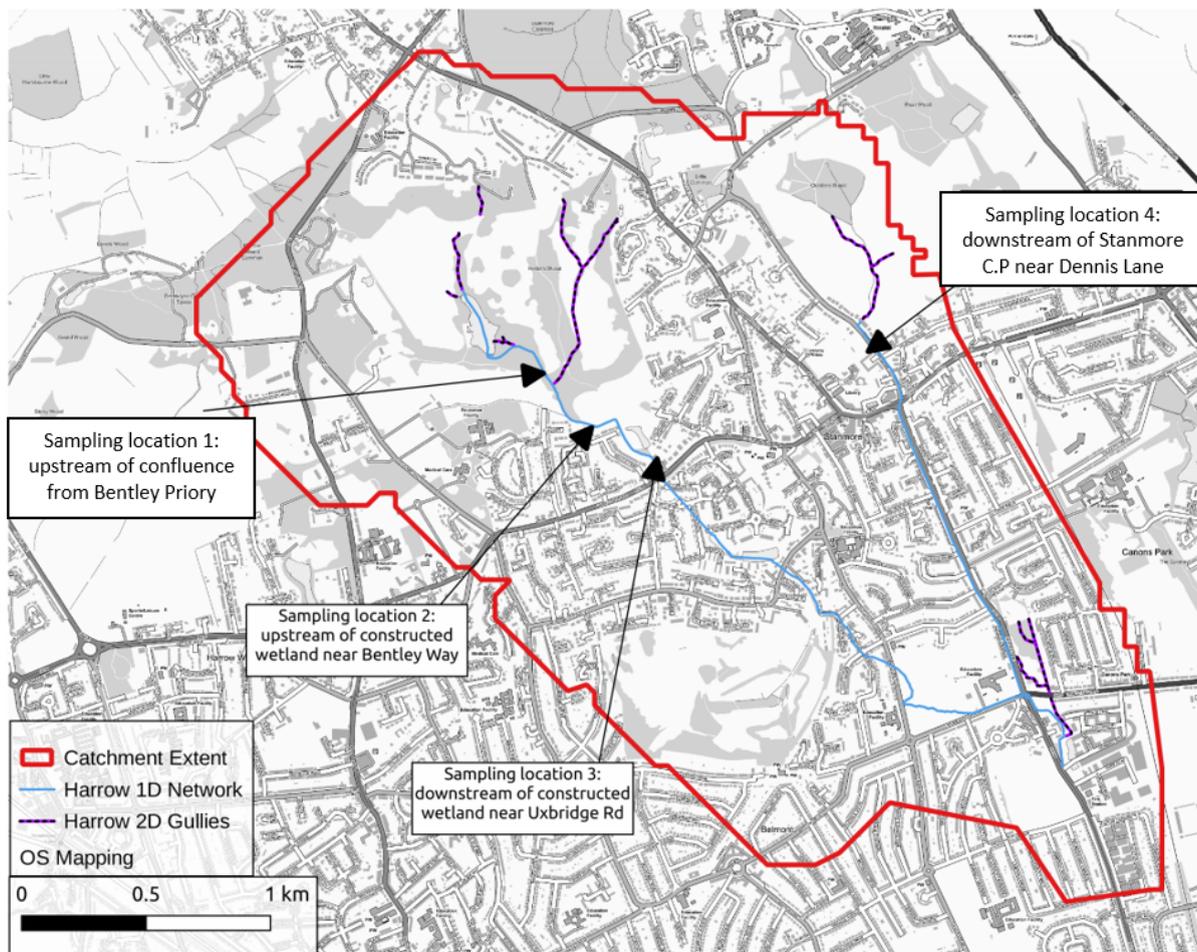
Figure 5: Extent of the model created by Edenvale Young Associates Ltd, indicating the extent of the 1D and 2D components and the locations where hydrographs of modelled results were taken.

Hydraulic modelling was carried out in ESTRY-TUFLOW, a one and two-dimensional distributed hydraulic model used for representing floodplain flow. The extent of the model is shown in Figure 5. It incorporated an existing model (1D-2D FMP-TUFLOW model) created by JBA Consulting Ltd in January 2019 for the Environment Agency which was shared with the project. Publicly available terrain data, OS Mastermap data and Cranfield soils data were incorporated in the 2D component.

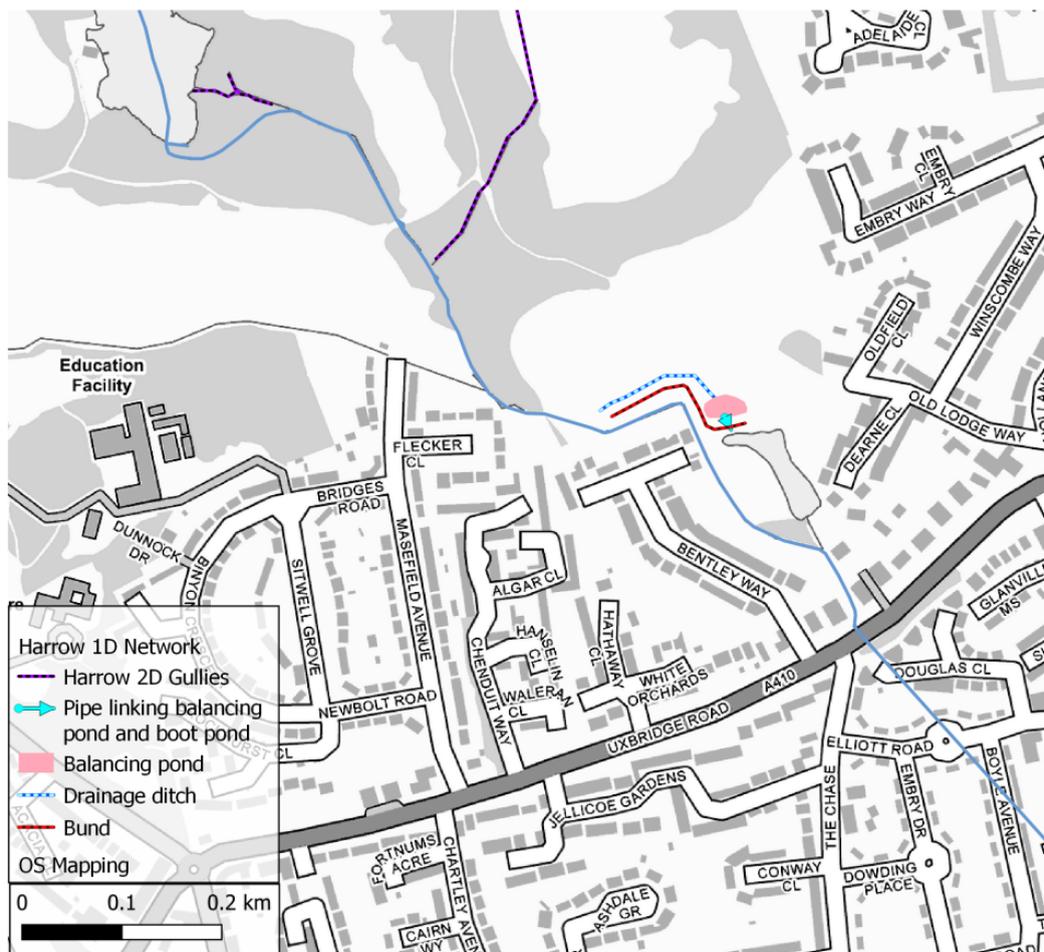
Figure 6: The bund, high flow channel and balancing pond modelled in Bentley Priory

iv) Scenarios of combined leaky dam and bund-pond measures to indicate maximum benefit in Bentley Priory

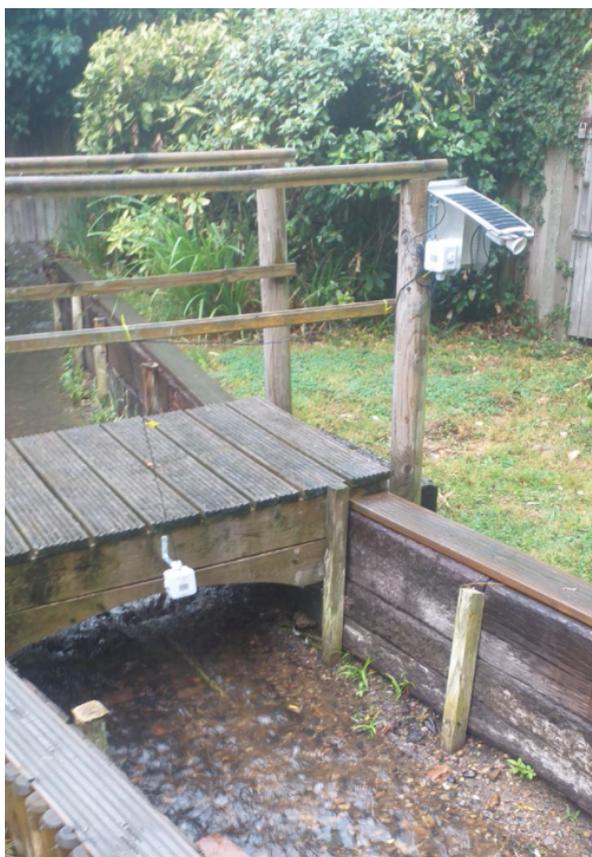
Figure 7: FreeStation water level monitoring device installed in a private garden in Bentley Way immediately downstream of Bentley Priory and the area where leaky dams were installed.

However, Bentley Priory had the benefit of the water course flowing through the private residences of gardens on Bentley Way immediately after exiting the wood, Figure 4. After entering into discussions with local residents, a FreeStation was installed in one of these gardens in August 2020, Figure 7.

This would not inform about changes in timings of hydrographs associated with individual dams, but had potential to capture the behaviour of the channel downstream of interventions during flow events, which may inform modelling. It was also an opportunity to engage local residents who were at risk of flooding.

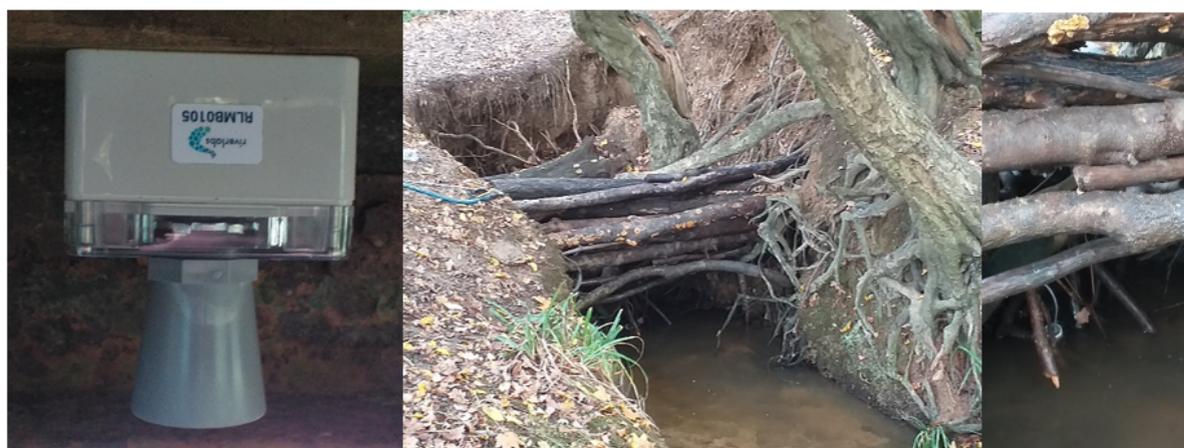
Figure 8: Imperial level logger (left) and deployed discreetly into a leaky dam in Bentley Priory (right)

In public places, battery (rather than solar) powered level monitoring devices that log data on board (rather than live streaming) are clearly more suitable because they can be hidden more discreetly. Imperial University are in the early stages of trialling such a logging device and one was attached to a leaky dam in Bentley Priory (Figures 4 and 8) upstream of a series of leaky dams. This was deployed in October 2020 in order to compare with the FreeStation downstream. Prior to installation, the Imperial logger was deployed in parallel with a FreeStation in the Salmons Brook catchment for a period of several months and it was ascertained that data were directly comparable between devices.

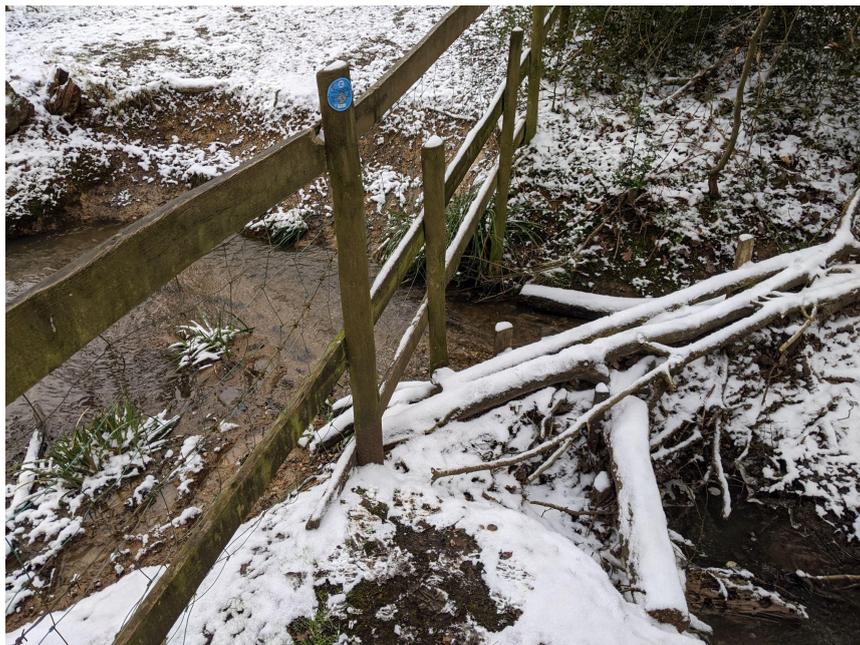
Figure 9: QR code (blue disc) deployed on a leaky dam in Bentley Priory.

After construction of the majority of dams, QR codes were installed on or near selected dams in Bentley Priory and Stanmore C.P. to further encourage woodland users and local residents to engage with the project (Figure 9) and as part of project legacy. Scanning the QR code connects users to Thames21's project web page containing information about NFM for flood risk mitigation, project volunteering opportunities and links for reporting dam state of repair and functioning.

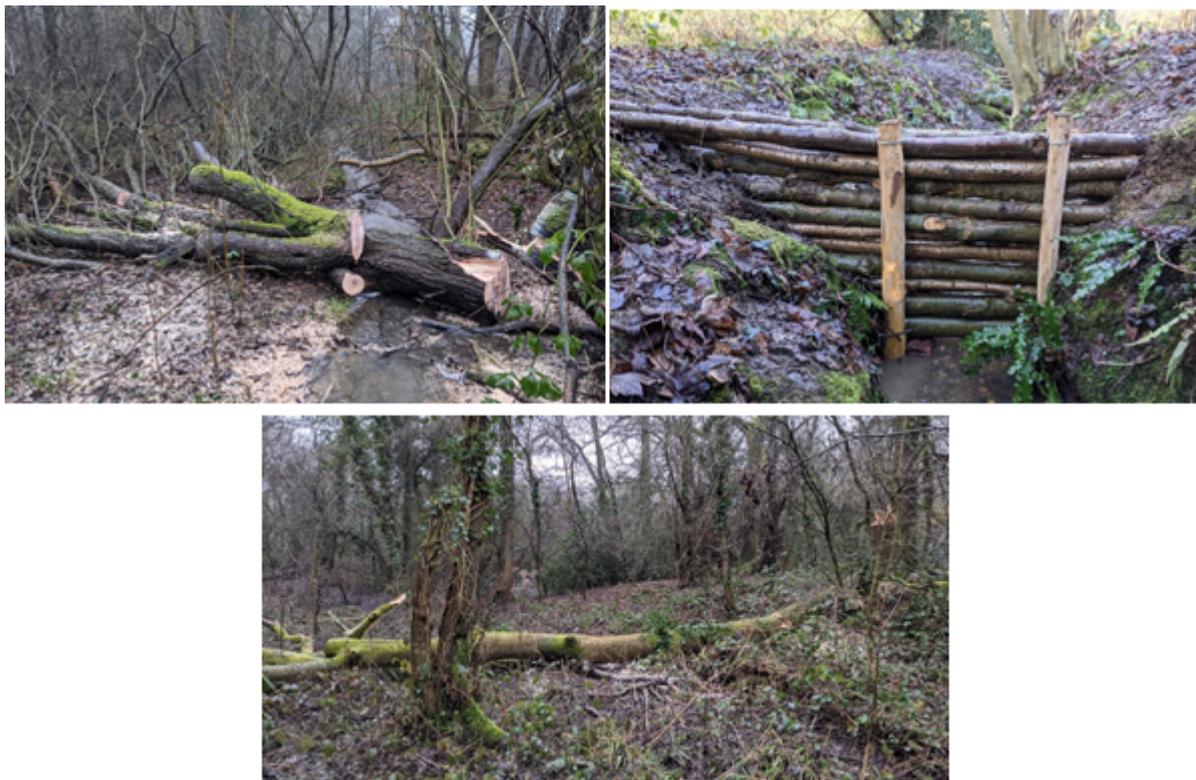
Figure 10: Examples of leaky dams and tree trunk dams installed in Bentley Priory and Stanmore Country Park . The tree trunk dam in the bottom example was intended to divert flows out of channel to infiltrate into the woodland floor.

Installation of woody debris dams across the channels slows the flow by temporarily storing water and increasing channel roughness. Additionally, rather than storing water, many of the dams were designed to divert flows out of the channel to infiltrate into the woodland floor, thereby reducing the volume of water in the channel. Examples of dams in Bentley Priory and Stanmore C.P. are shown in Figure 10. The increase in storage volume and area of channel roughness created are summarised in Table 4.

Once the storage area behind the dam is full, it ceases to detain any further flow and water weirs over the top of the dam. The degree of ‘leakiness’ of dams in terms of how much water is let through the structure and also the speed with which water infiltrates into the underlying substrate (related to antecedent weather conditions as well as geology) will impact the storage capacity of dams and its ability to impact the timing and volume of peak flows. The impact of these aspects was characterised by flood risk modelling and from volunteer reports during flow events.

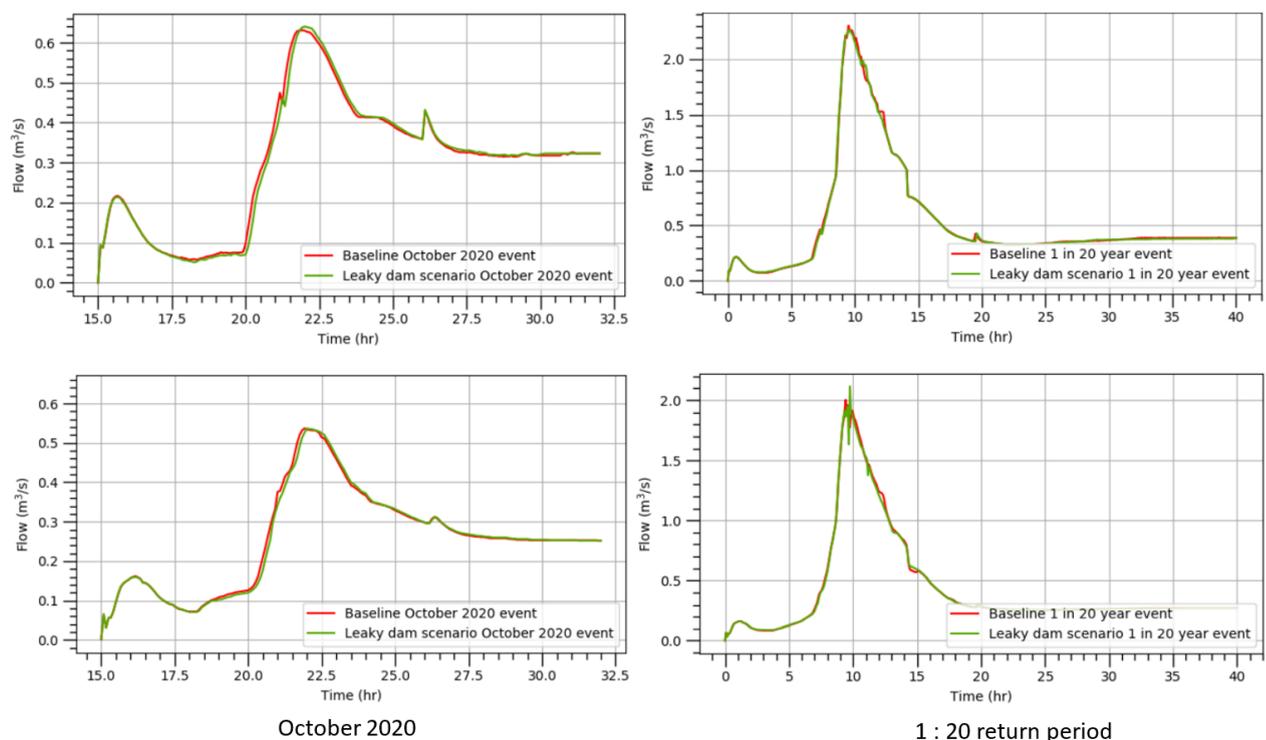
Figure 11: Hydrographs of performance of leaky dams in Bentley Priory during the October 2020 event (left) and a 1:20 year return period event (right). Scenarios with (green) and without (red) the leaky dams were sampled from top: just north of Bentley Way and; bottom: at the southern end of Bentley Priory at Uxbridge Road (locations 2 and 3, Figure 5).

All dams (proposed and built) were modelled and results indicate only a marginal impact on downstream flood risk at either site. The maximum reduction in peak flows is approximately 3% near Bentley Way during the October 2020 event, with no meaningful change in peak timing. This drops to 2% reduction in peak flow in a 1:20 year return period event and no reduction in peak volume or timing in a 1:100 year event, Figure 11, Appendix 1. This means the effects of the leaky and tree trunk dams are only detected in smaller rainfall events. In Stanmore C.P., there is no perceived impact in the timing or height of the flood hydrograph taken at any temporal scale, Figure 12.

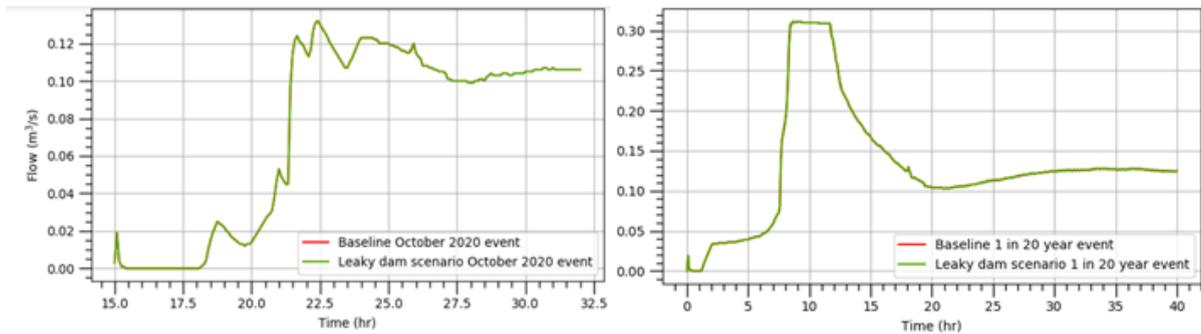
Figure 12: Hydrographs of the performance of leaky dams in Stanmore C.P. during the October 2020 event (left) and a 1:20 year return period event (right). Scenarios with (green) and without (red) the leaky dams were sampled from Dennis Lane (location 4, Figure 5).

This means that leaky dams are only minimally effective at reducing flood risk. These results are consistent with the modelled results of the performance of the leaky dams in the other three NFM pilots - all of which found minimal or no impact of leaky dams on flood risk reduction.

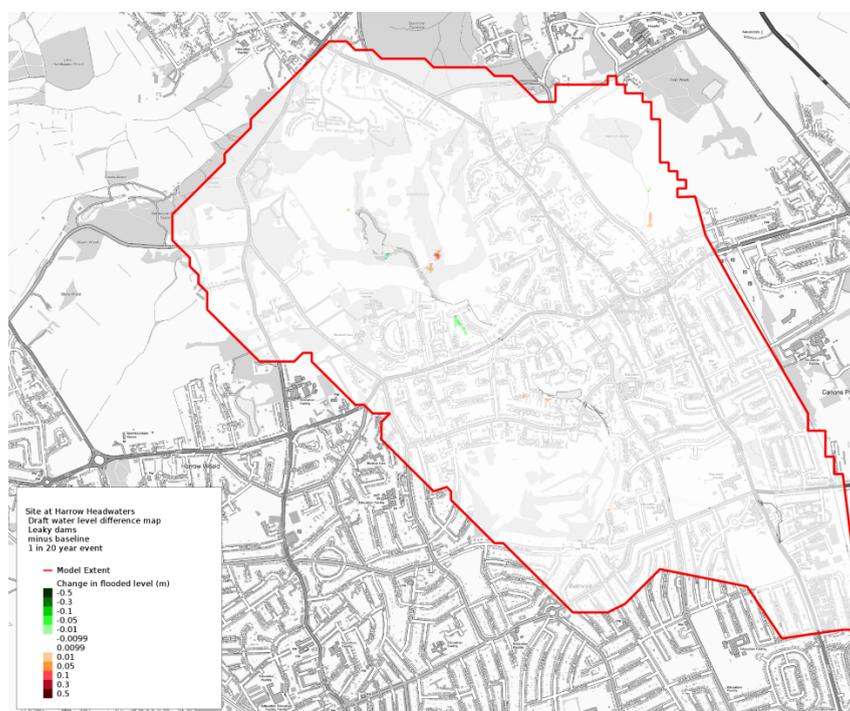
Figure 13: Modelled peak water level differences between the scenario with the leaky dams and a baseline scenario with no dams during a 1 : 20 year return period event.

Peak water level difference mapping indicates an increase in water levels in Bentley Priory and Stanmore C.P. of 250 mm and 29 mm respectively. This is associated with the dams holding back water and is contained within the woodland and therefore does not increase risk to properties, Figure 13.

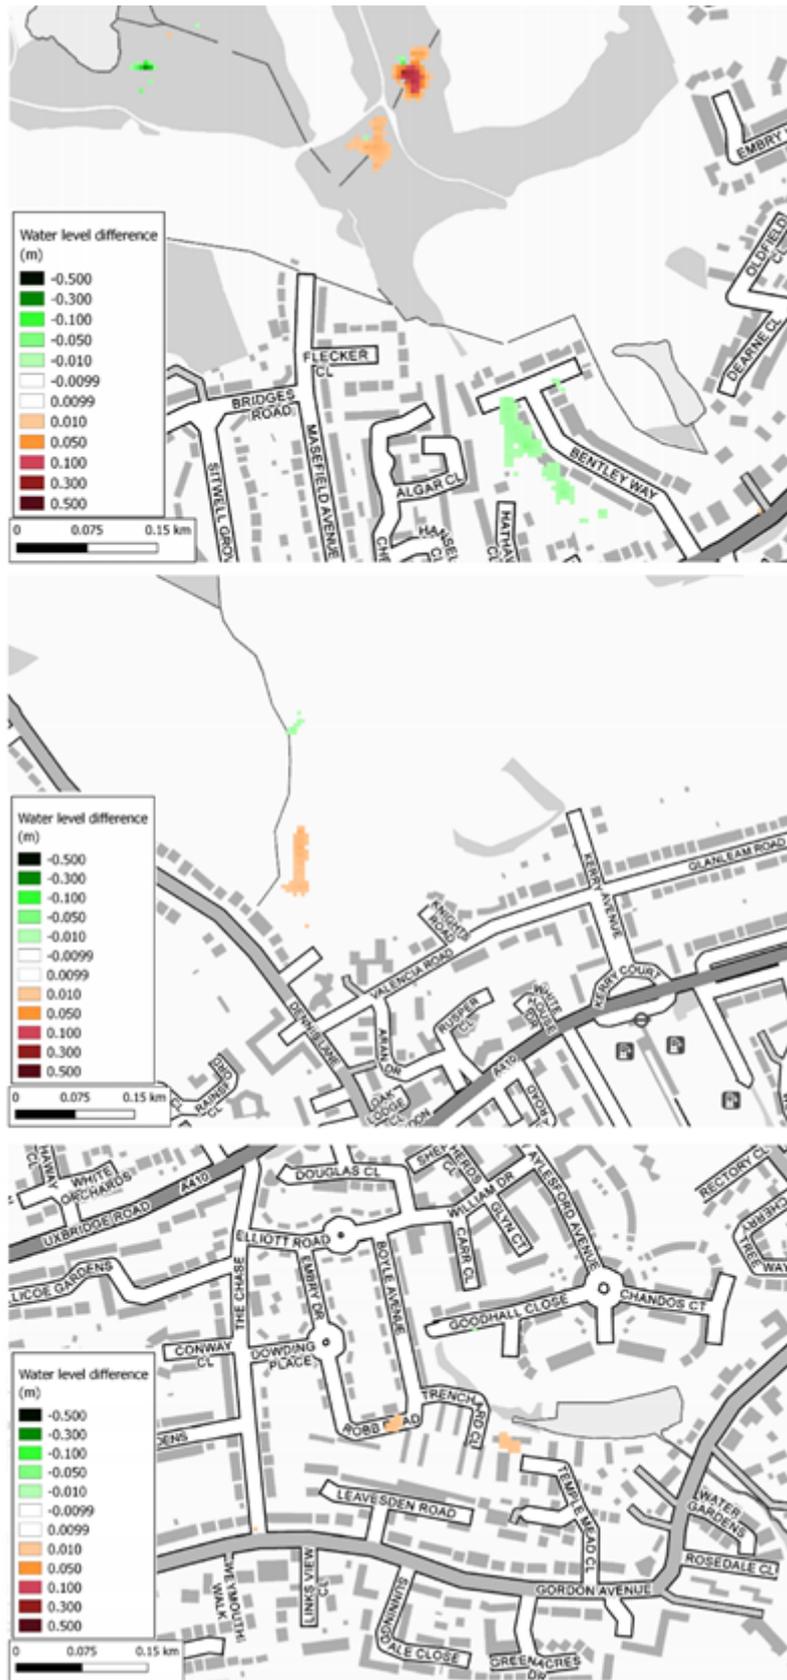
Figure 14: Peak flood water level differences in a scenario incorporating leaky dams compared to the baseline without leaky dams during a 1:20 year return period event, taken from Figure 13: a) Bentley Priory, b) Stanmore C.P. and c) downstream in the vicinity of Temple Pond.

Figure 14 focuses on areas of interest from Figure 13. In particular the reduction in peak flood water levels (by approx 50 mm) in Bentley Way during a 1 : 20 year return period event. The increased water levels by approx 15 - 20 mm in Robb Road (Figure 14c) is unlikely to represent a 'real' increase in flood risk. This location is far downstream of the leaky dams and there are many other inflows between the dams and this location - not least from Thames Water's surface water drainage network, which was modelled with many assumptions.

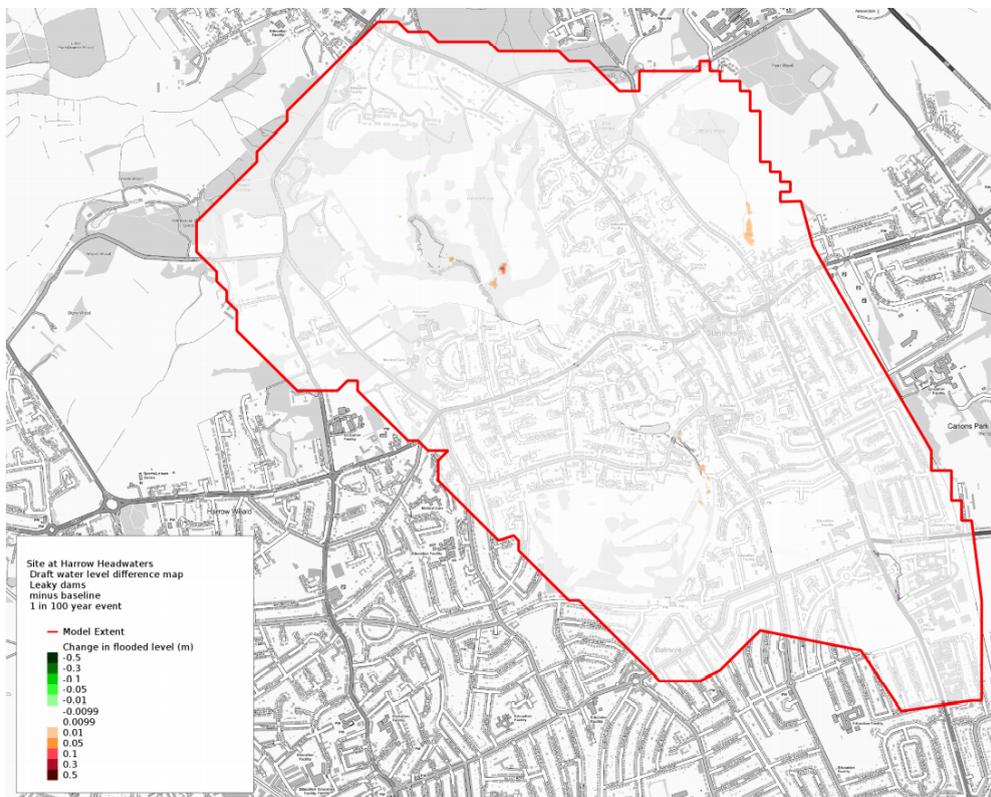
Figure 15: *Modelled peak water level differences between the scenario with the leaky dams and a baseline scenario with no dams during a 1 : 100 year return period event.*

During a 1 : 100 year event, peak water level difference mapping indicates water level increases in Bentley Priory (260 mm) and Stanmore C.P. (62 mm) respectively in association with the leaky dams. There is also a possible increase in water level at the location of one house on Dennis Lane (11 mm) and downstream at Wolverton Road (42 mm), Figures 15 and 16. There is no change in peak height or timing demonstrated in the hydrographs (Appendix 1).

Once again, it must be stressed that modelled results are unlikely to be the results of the leaky dam interventions, in particular the elevated water heights far downstream in the Temple Pond area during the October 2020 and 1 : 20 year return events.

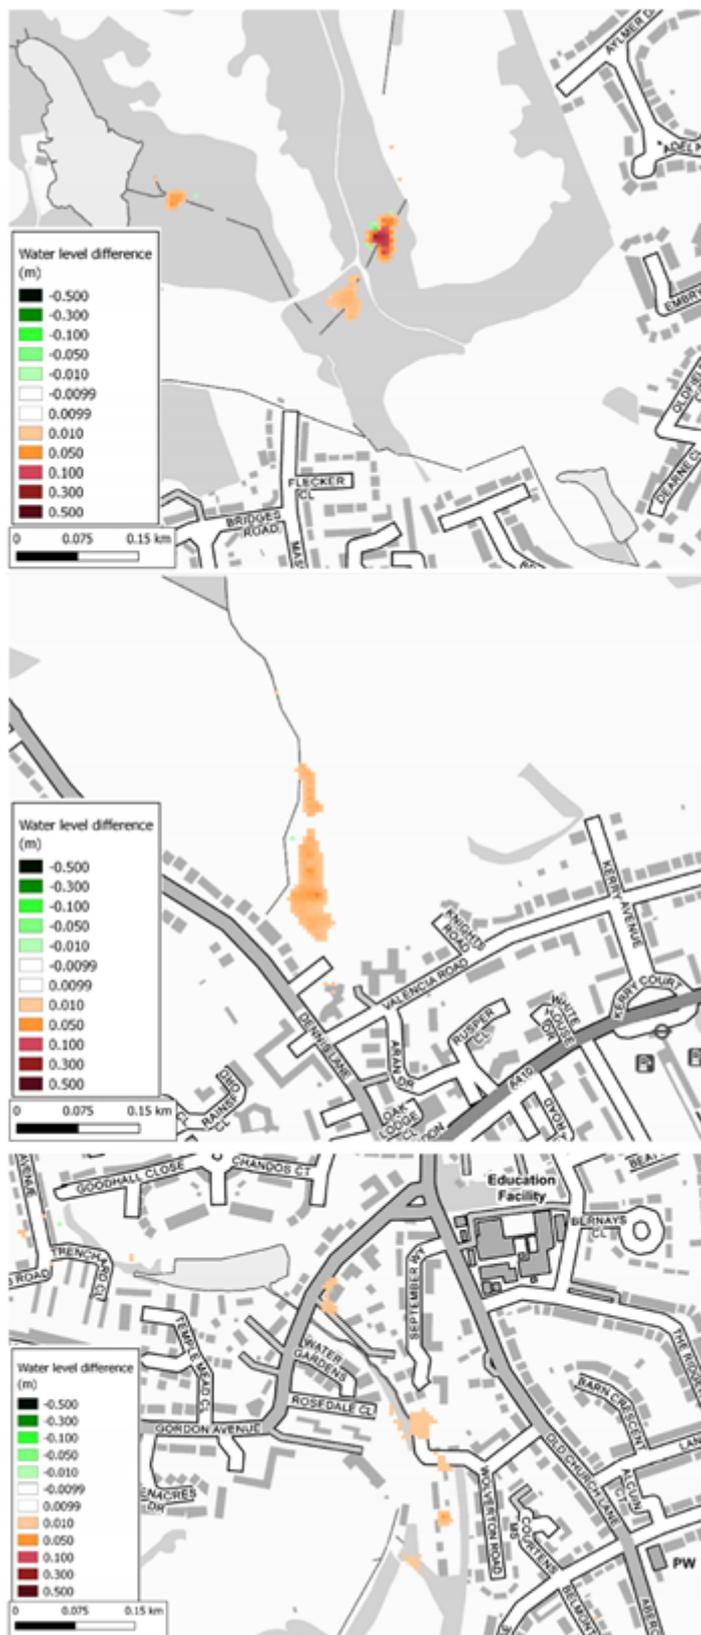
Figure 16: Peak flood water level differences in a scenario incorporating leaky dams compared to the baseline without leaky dams during a 1:100 year return period event, highlighting key aspects of Figure 15 at: a) Bentley Priors, b) Stanmore C.P. and c) downstream in the vicinity of Temple Pond.

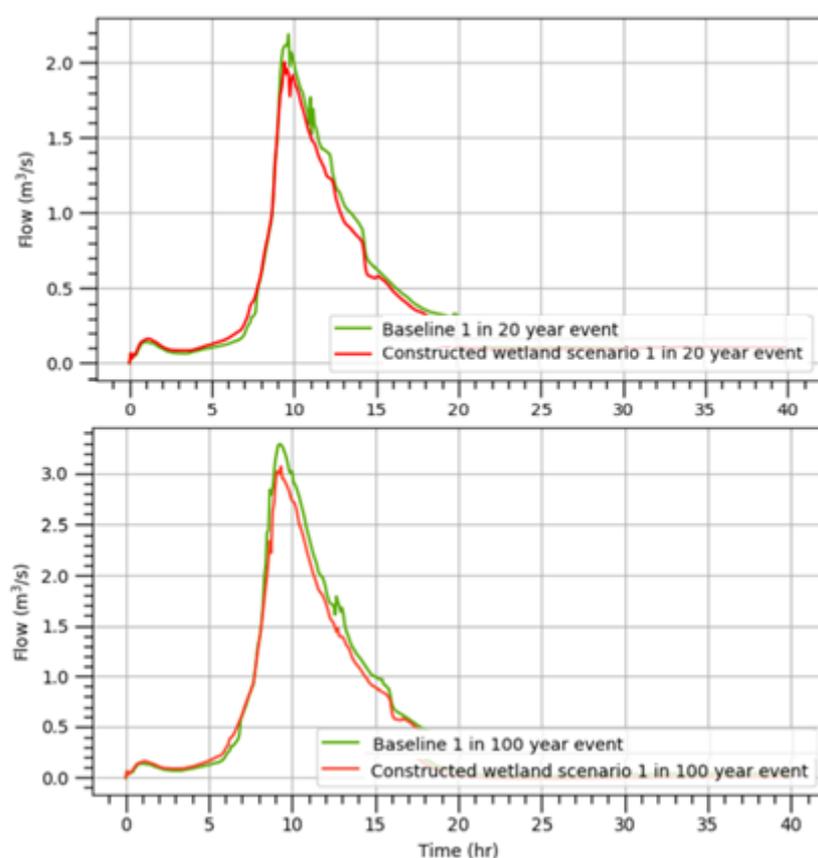
Figure 17: The performance of bund and balancing pond in Bentley Priory during a 1:20 year (top) and 1 : 100 year return period event (bottom) without (green) and with (red) the leaky dams. Hydrographs were sampled from just below the pond feature near Uxbridge Road (location 3, Figure 5).

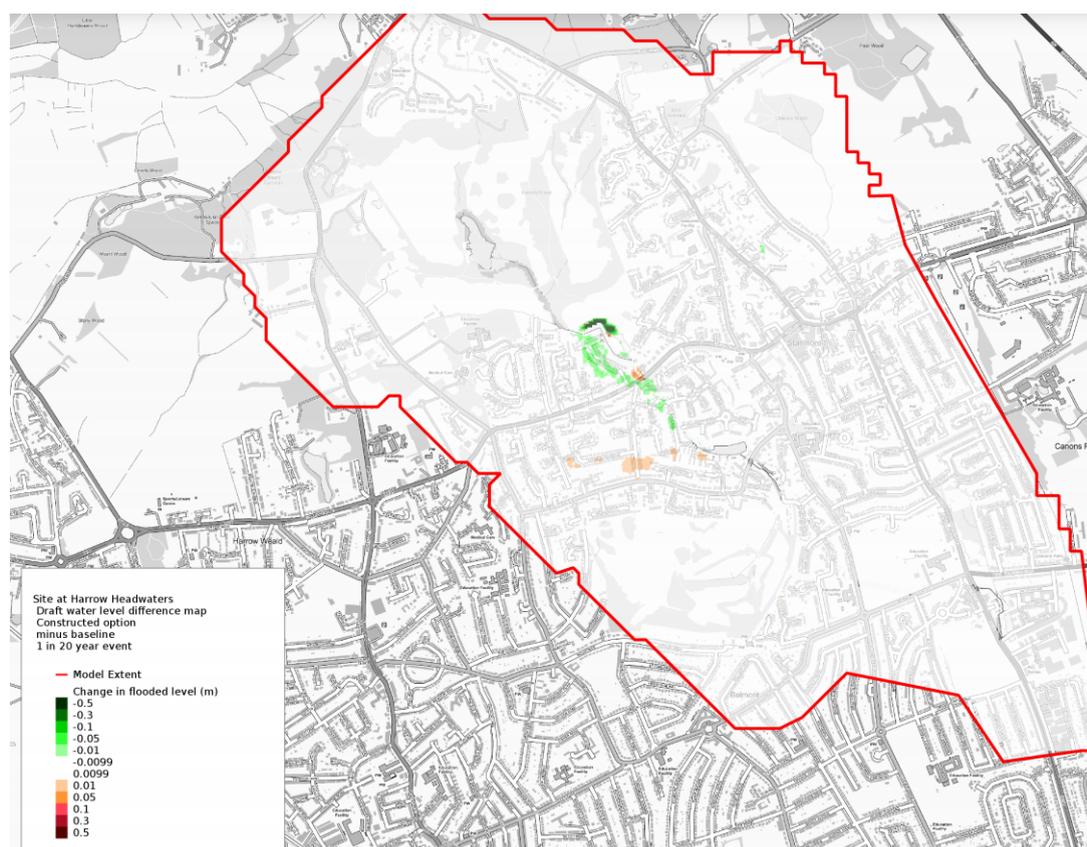
Figure 18: Modelled peak water level differences between the scenario with the channel and balancing pond and a baseline scenario without during a 1 : 20 year return period event.

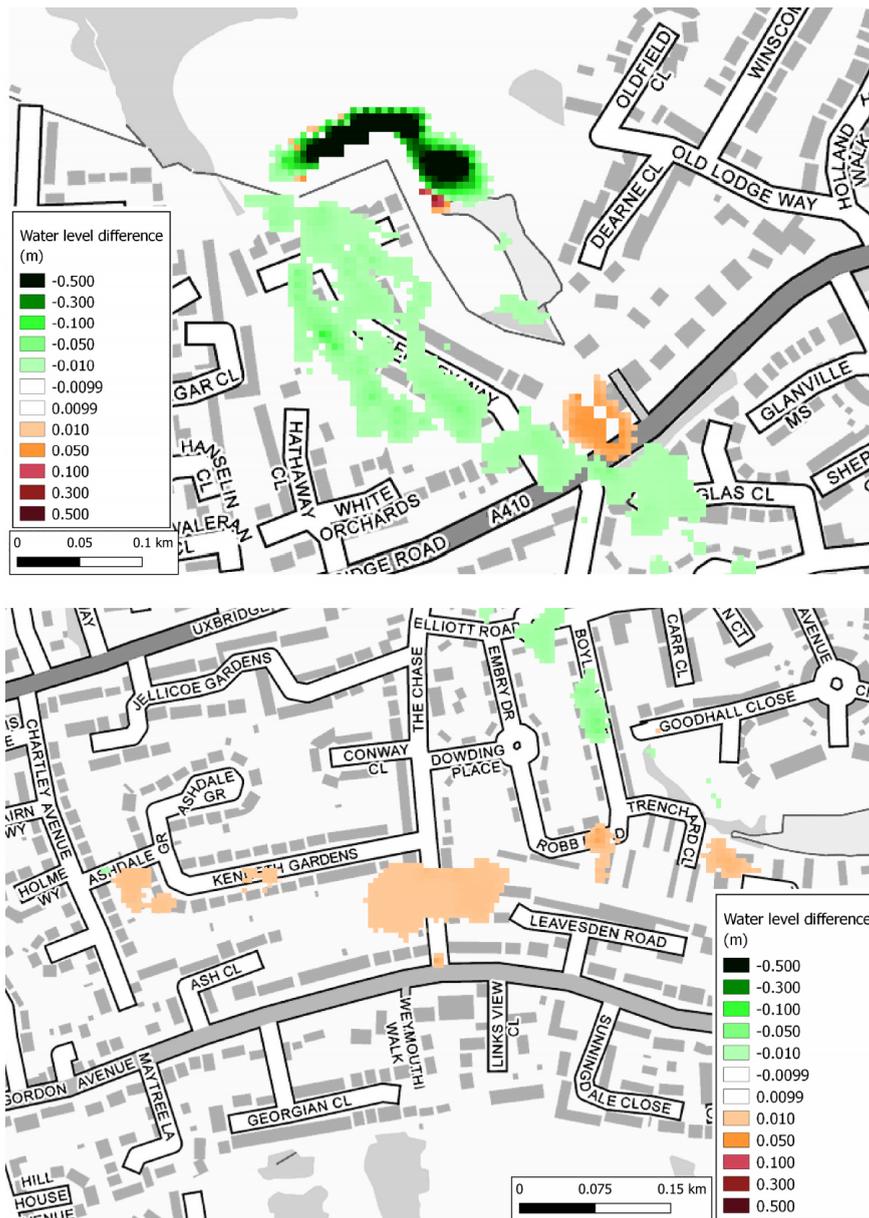
Figure 19: Peak flood water level differences in a scenario incorporating the balancing pond and bund compared to the baseline without during a 1:20 year return period event, highlighting key aspects of Figure 18 at: Bentley Priory (top) and downstream in the vicinity of Temple Pond (bottom).

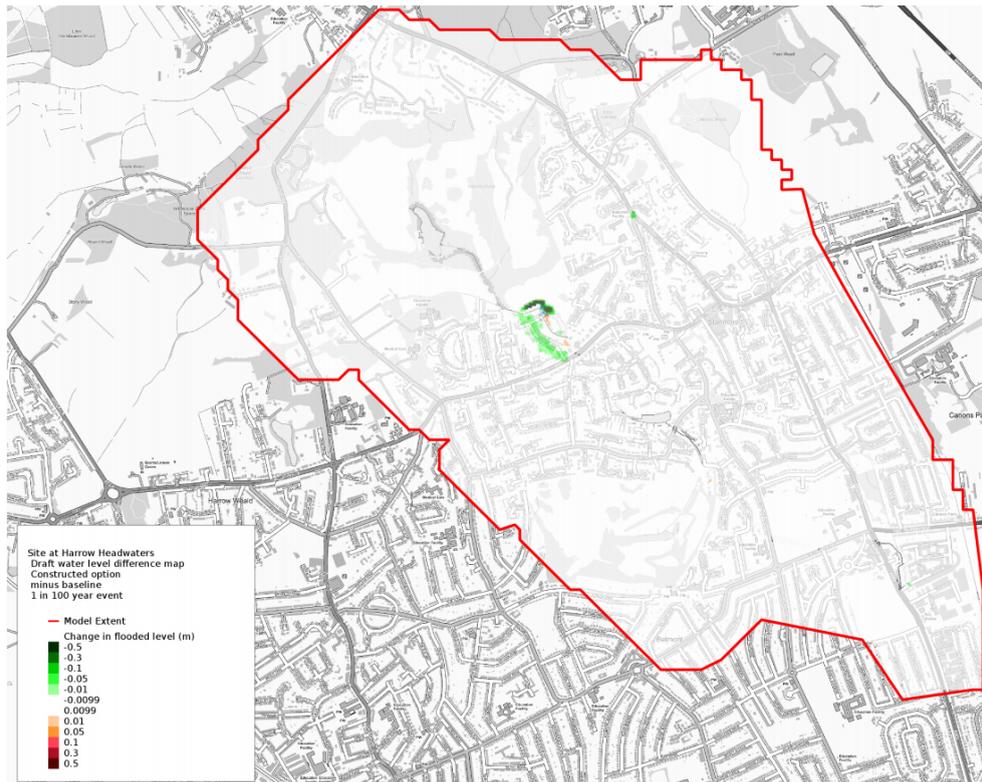
Figure 20: Modelled peak water level differences between the scenario with the channel and balancing pond and a baseline scenario without during a 1 : 100 year return period event.

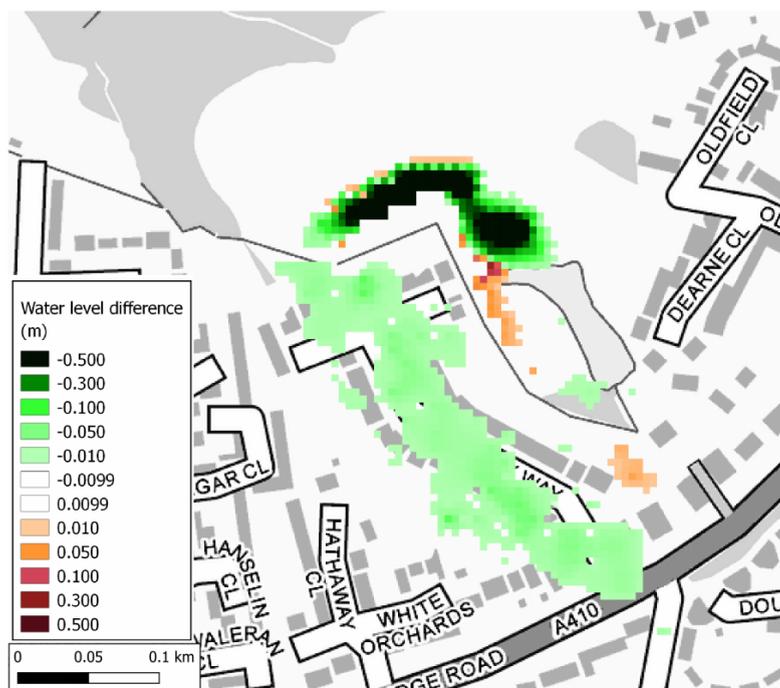
Figure 21: Peak flood water level differences in a scenario incorporating the balancing pond and bund compared to the baseline without during a 1:100 year return period event, highlighting key aspects of Figure 20 at Bentley Priory.

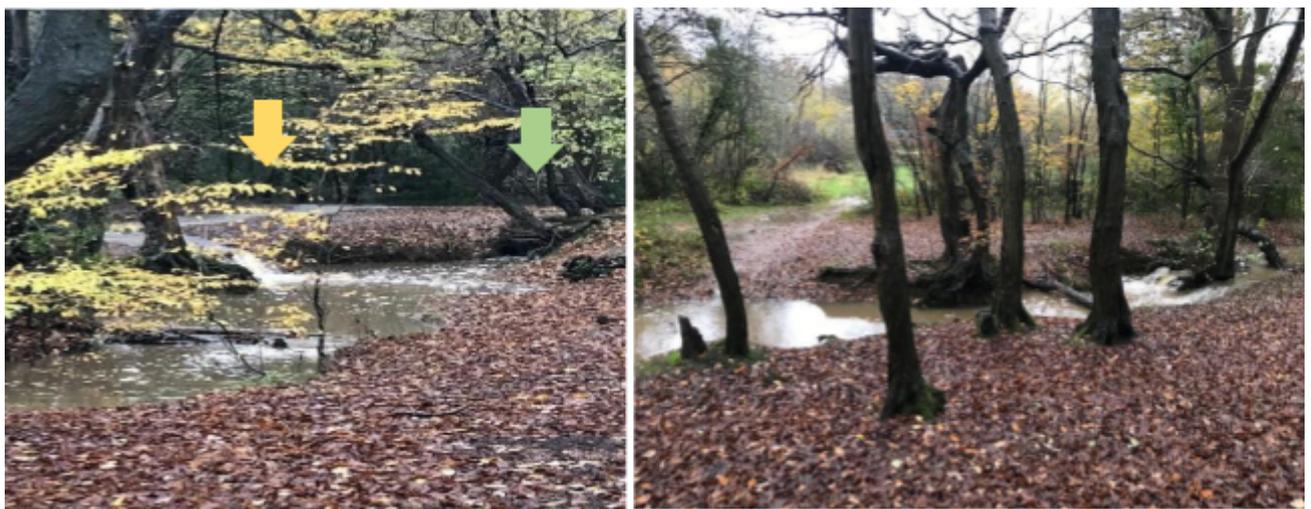
Figure 22: *Volunteer photos of flow behaviour in Bentley Priory after heavy rainfall caused flooding in October 2020. Volunteer photos were invaluable for documenting significant overland flow through the woods (left, yellow arrow) that bypassed a dam with a water level logger (green arrow) and overland flow occurring on footpaths (right). Note also the river channel still had capacity, despite flooding gardens.*

Volunteers at flood risk from the vicinity of Bentley Priory visited the woods and documented behaviour of the woodland and leaky dams during rainfall, including an event (linked in part to blocked drains) that resulted in flooding in October 2020 (Figures 3, 22 and 24). As shown in these figures, photographs submitted by volunteers create useful snapshots of Bentley Priory under certain conditions and increased understanding of overland flow paths through the woods, known to activate in high rainfall. This was above and beyond the capacity of project officers, who cannot be reactive to events as they occur. In this way it was discovered that significant flow was exiting the channel upstream of the dam to which the Imperial level logger was fixed, therefore informing that the logger was recording an incomplete picture of flow events. It also informed that flow held behind some dams was spilling onto footpaths which prompted tweaks to the design. It also identified places where flow deflecting timbers should be placed to keep flow in channel. Photos and characteristics of events were sent to Edenvale Young to help inform the modelling.
