Woodland and river management in two headwater streams, NFM Pilot: results and lessons

The Harrow headwaters NFM project is one of four Community Scale NFM pilots awarded £50,000 and delivered by Thames21 in partnership with the local council and community. This report discusses key results and lessons learned from the installation and monitoring of 29 leaky dams and 11 tree trunk dams in Bentley Priory and Stanmore Country Park, West London, by evaluating NFM effectiveness and the process of partnership working. Evaluation of the dams comprised hydrological modelling, water level sensors and volunteer reports and photographs, including development of an app. Wider benefits of the NFM were assessed by geomorphological surveys (MoRPh) and ecology surveys.

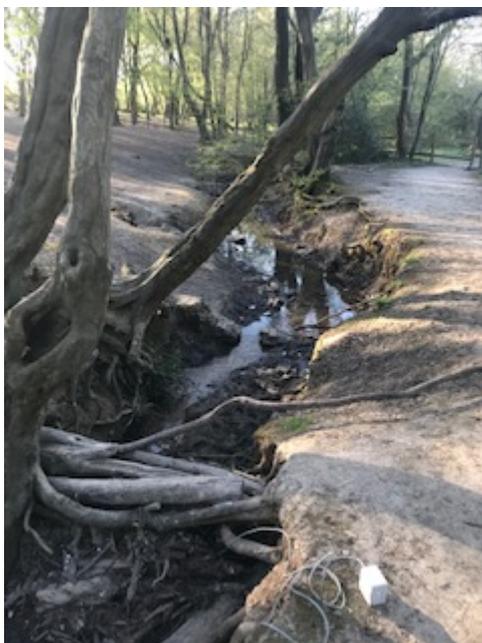
Figure 23: Volunteer photo alerting project staff to the Imperial data logger removed from its place of concealment within a leaky dam in Bentley Priory.

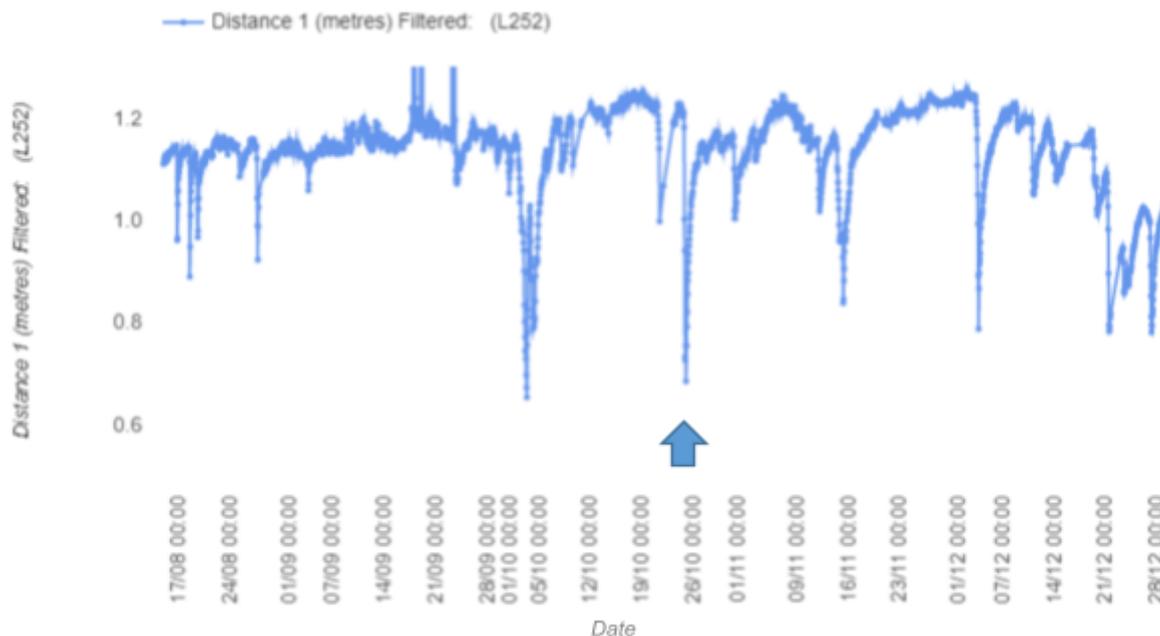
Figure 24: Example telemetry data for the period 15th August 2020 – 31st December 2020 from a FreeStation hosted by a volunteer in a private garden on Bentley Way (Figure 7), just downstream of the area of Bentley Priory where leaky dams were installed. Data show distance in metres between the sensor and water surface, the October 2020 event that led to garden flooding is indicated as a blue arrow.

The station was deployed later than those in the other pilots, once many issues had been resolved, and was located in ideal conditions – i.e. an exposed location with good sunlight receipt for battery charging and adequate distance from trees, bridges and other structures to generate and upload data continuously. An added benefit of installation in the private garden of a volunteer was immediate detection and rectification should the sensor be knocked out of alignment (e.g. by animals rubbing their heads on it or debris in high flows) or by vegetation or spider webs interfering with the beam.. It therefore requires little maintenance by project staff after installation.

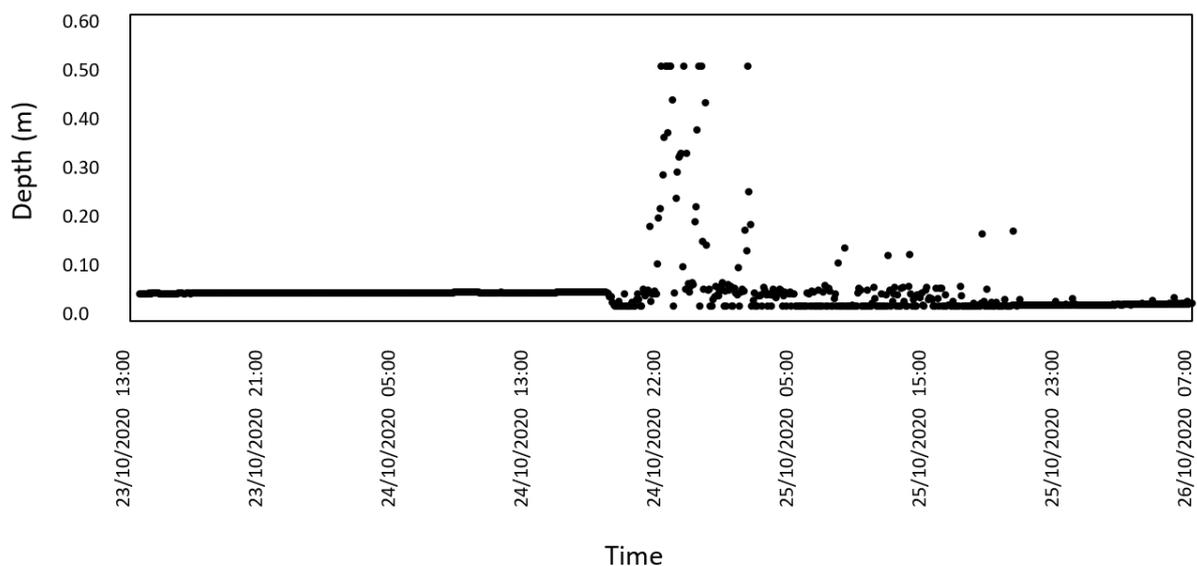
Figure 25: Water depth at a leaky dam in Bentley Priory during the October 2020 flood event used in model calibration. Data are derived from a level logger supplied by Imperial University. (Levels not to ordnance datum). Note, significant water flow bypassed the upstream logger as overland flow so data are not representative of channel flows (see Figure 22).

Whilst representing a much better choice for peri-urban catchments, it should be noted that deployment of the level loggers from Imperial University still has its challenges. The sensor requires mounting over the water therefore deployment on the underside of bridges or incorporation into leaky dams are options. In both these locations the sensor had a tendency to inundate in the highest flows resulting in loss of data at the peak of the hydrograph. The alternative would be to mount the sensor on a post mid channel above high water level, but the compromise is loss of discretion and increased vandalism risk.

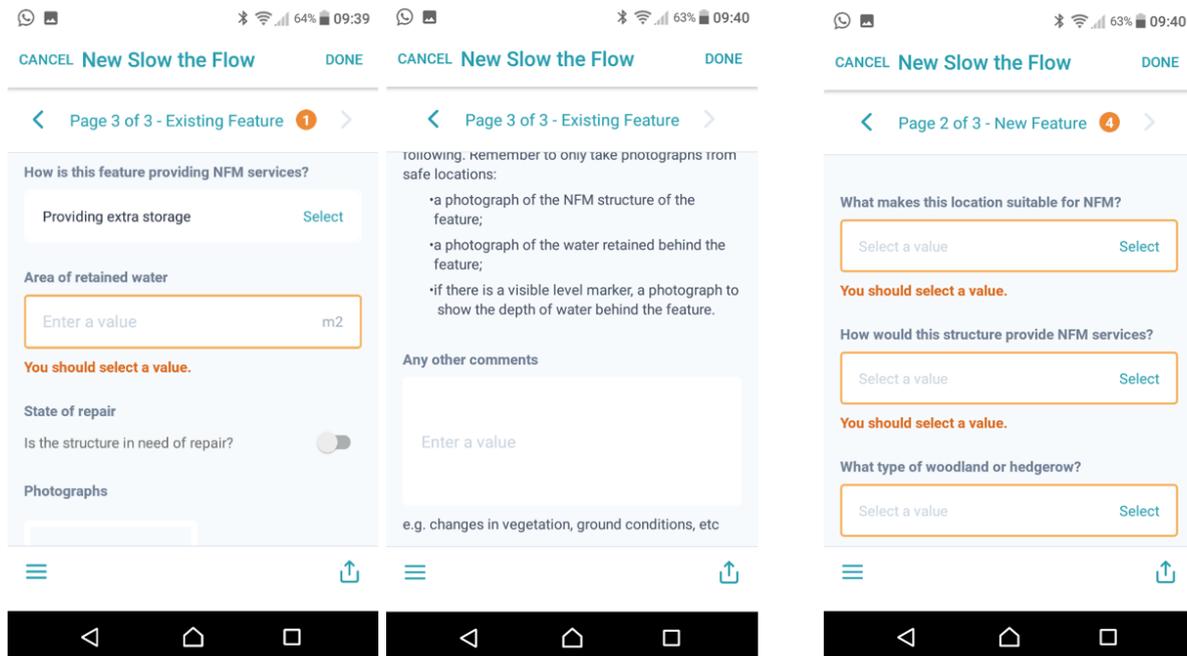
Figure 26: Screenshots of the SlowFlowCapture App for collection of data about the NFM assets by the public and trained volunteers. Left and centre: recording data for existing features; right: recording suggestions for a new NFM feature.

Data collection options included both i) suggestions for sites in the four NFM pilot locations that may be suitable for installation of NFM and ii) information about state of repair and functioning of existing NFM features. Figure 26 shows screenshots of the app, which also prompt the user to upload photos and more general comments about changes that may be associated with the leaky dams.

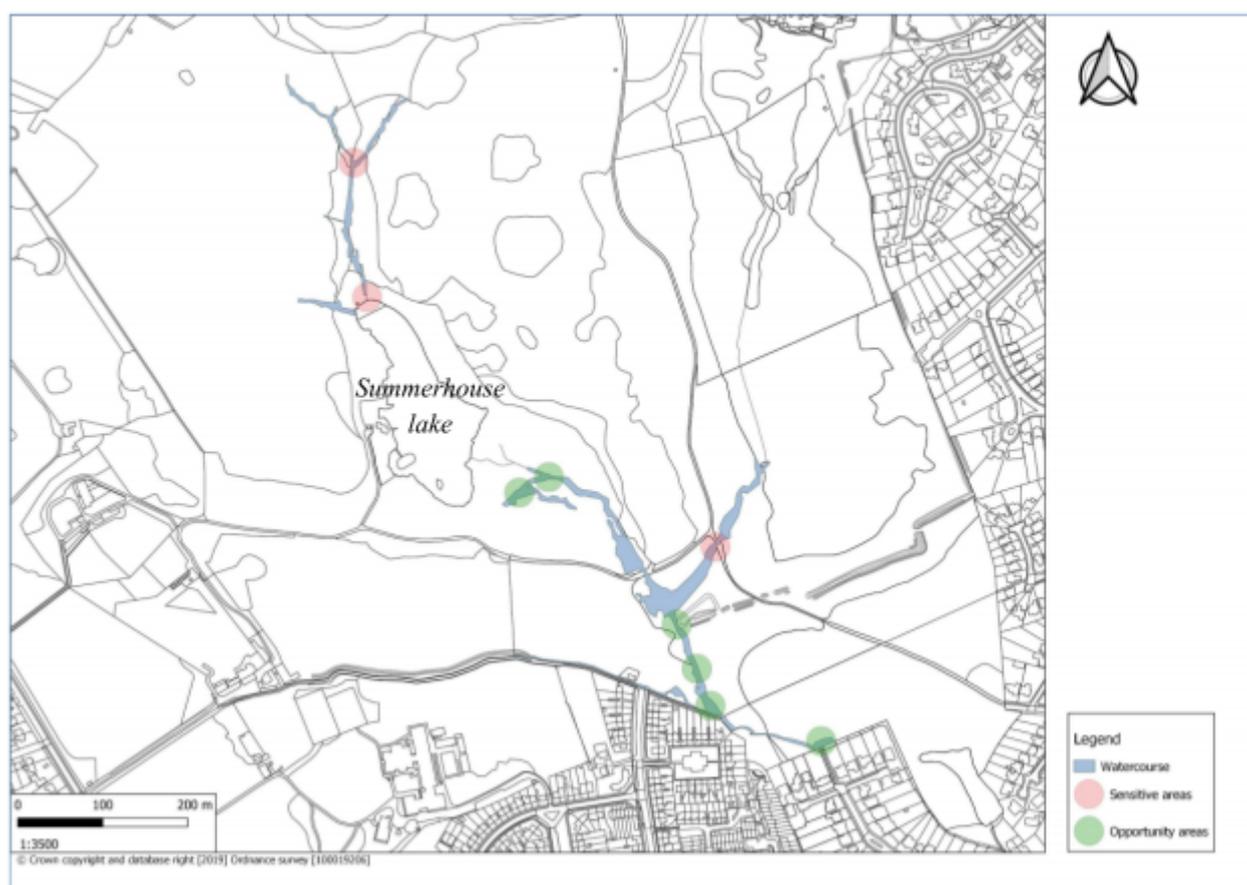
Figure 27: Opportunities and constraints for NFM interventions in Bentley Priory identified from ecology surveys undertaken in 2019 and 2020 [Denis J Vickers (Consultant Ecologist)]

These wetland areas with associated wetland species may be sensitive to altered or reduced flows. It was therefore recommended that no dams be installed within 50 m upstream of

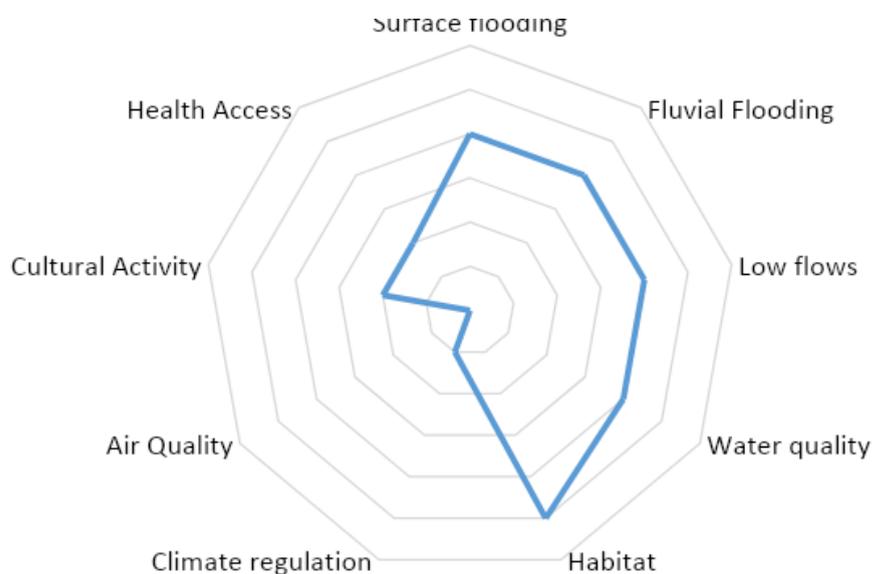
Figure 28: Potential multiple benefits of leaky dams in Bentley Priory and Stanmore C.P., after they are more established.

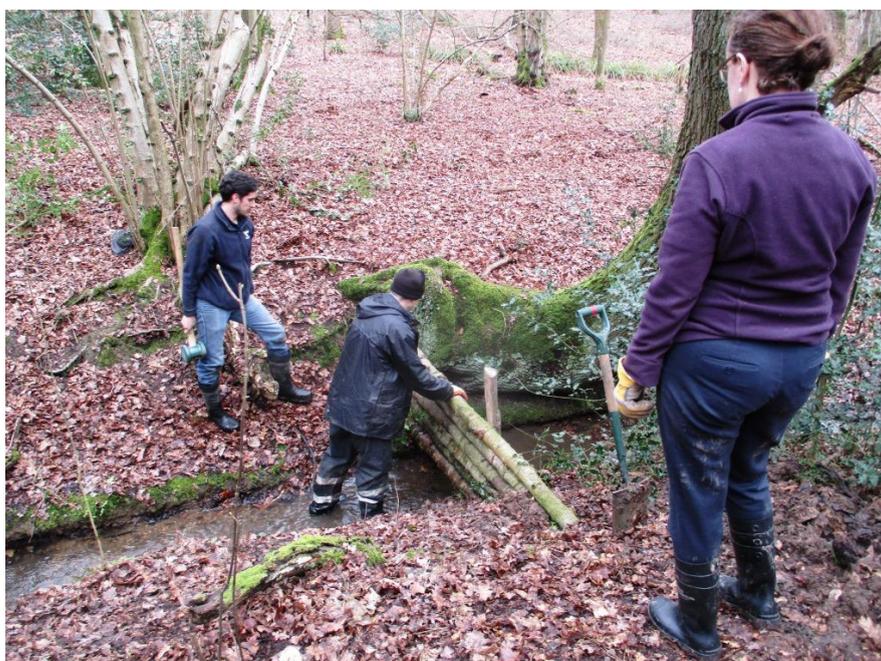
Figure 29: Leaky dams constructed with volunteers in Stanmore CP.

In addition to the training course, volunteers were recruited to assist with leaky dam building. In total 8 leaky dam building events were scheduled but due to Covid-19 restrictions only 2 went ahead in Bentley Priory. These took place between November 2019 and December 2020 and involved 7 volunteers building 5 dams. In Stanmore C.P., 7 dams were built by 8 volunteers over 2 events, Figure 29. Monitoring and the Slow Flow app were also introduced at these events.

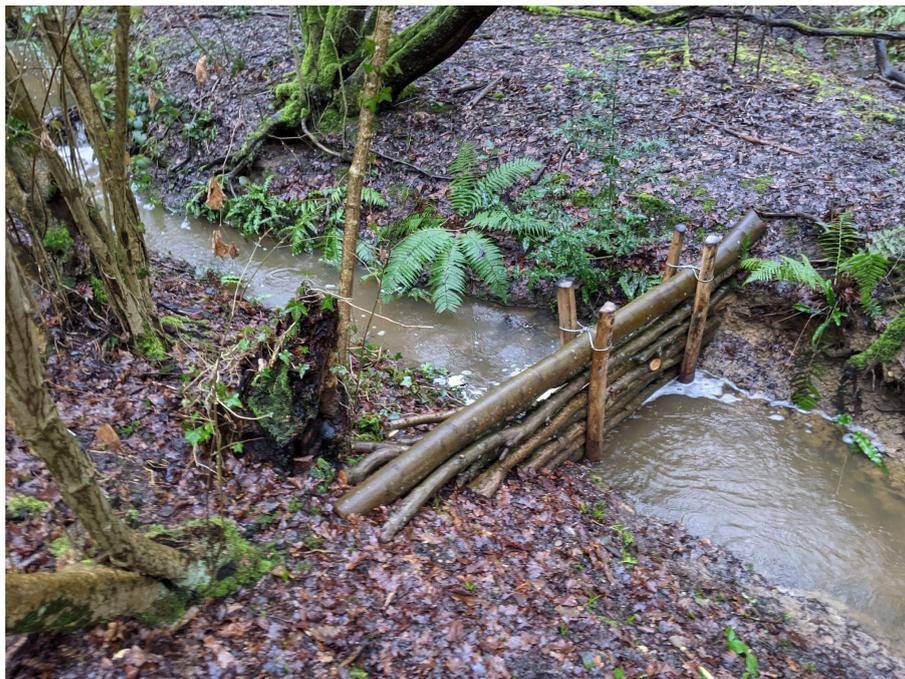
Figure 30: Wiring as a measure to deter vandalism and timber removal of leaky dams in Stanmore C.P.

The horizontal elements of leaky dams constructed early in the project were not secured in place. Based on learning from the other pilot projects where vandalism was experienced, dams built later were secured with discrete wiring to prevent tampering, Figure 30. QR codes should be installed on the smaller, less formal-looking trunk dams in order to prevent accidental removal.
