# The River Pinn Park Wood NFM Pilot: results and lessons

MARCH 2021

The River Pinn Park Wood NFM project is one of four Community Scale NFM pilots awarded £50,000 and delivered by Thames21 in partnership with the local council and community. This report discusses key results and lessons learned from the installation and monitoring of 50 leaky dams in Park Wood, West London, by evaluating NFM effectiveness and the process of partnership working. Evaluation of the dams comprised hydrological modelling, water level sensors and volunteer reports and photographs, including development of an app. Wider benefits of the NFM were assessed by geomorphological surveys (MoRPh) and ecology surveys.

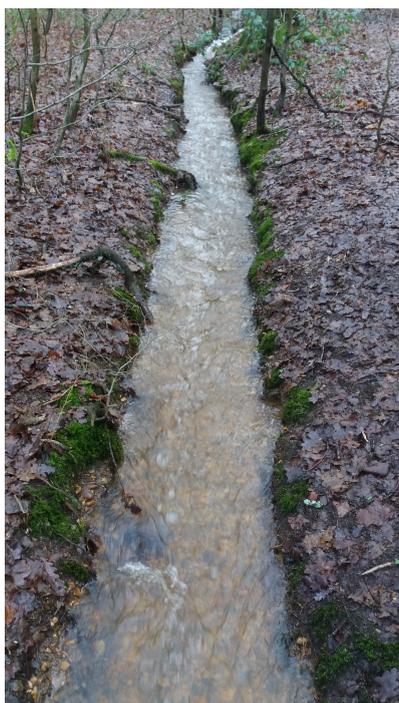
Figure 1: Park Wood and the River Pinn.

Park Wood (51.589142, -0.423983) is a National Nature Reserve (NNR) and Site of Special Scientific Interest (SSSI), part of the wider Ruislip Woods SSSI, comprising some of the largest unbroken blocks of semi-natural, ancient woodland in Greater London. The predominantly oak-hornbeam-yew woodland is dissected by small valleys whose water courses and damp flushes drain into the River Pinn, located 330 metres from the woodland boundary.

There is a network of watercourses and informal flow paths within Park Wood that converge along the southern boundary of Park Wood where the watercourse is conveyed in a culvert beneath Park Avenue and Broadwood Avenue towards the River Pinn. As well as being artificially straightened in sections to speed up land drainage (left),

This document, delivered in collaboration with the London Borough of Hillingdon and the local North Ruislip Flood Action Group (NRFLAG), reports on the above objectives and lessons learned from a Community Scale NFM project in Park Wood, located in the London Borough of Hillingdon in the catchment of the River Pinn in north-west London, Figure 1.

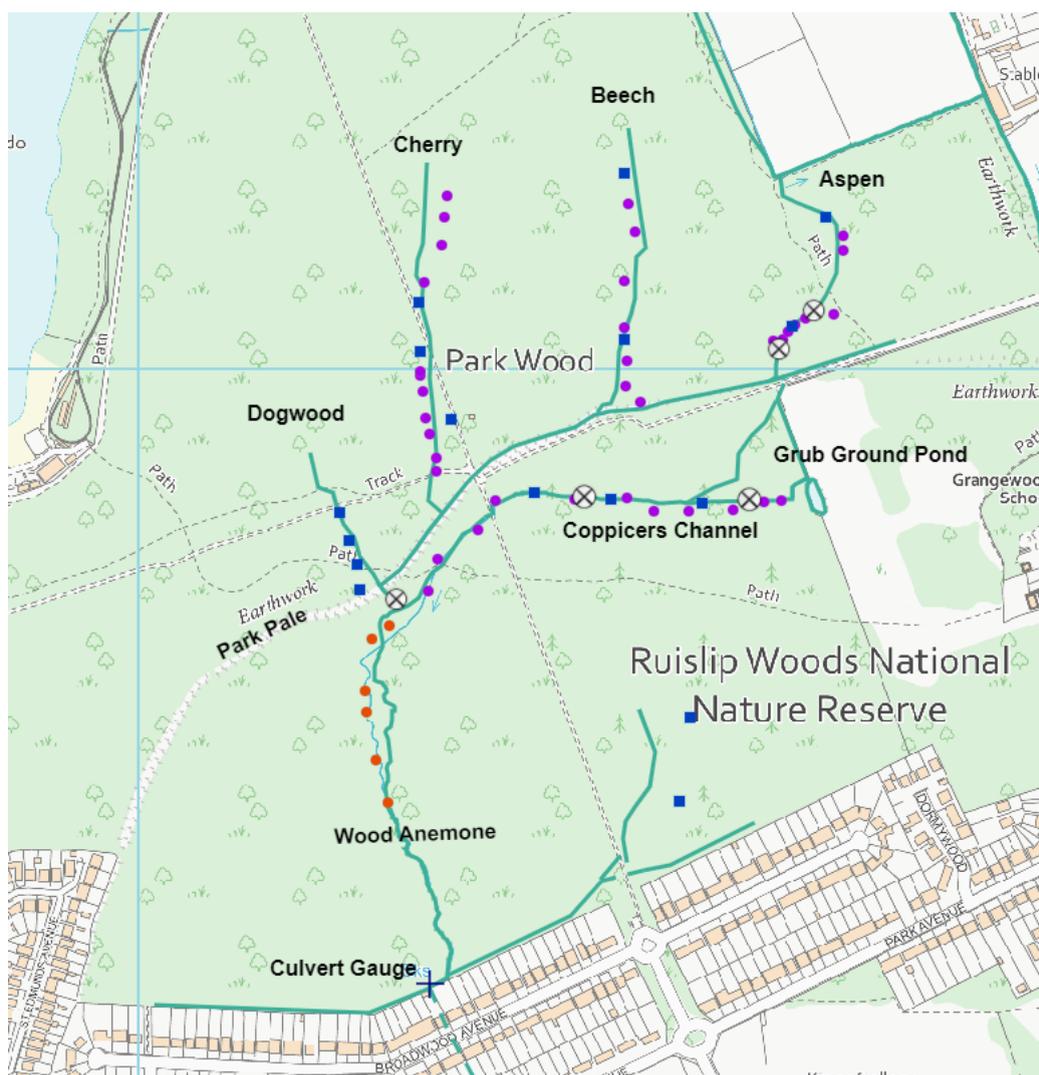
**Figure 3:** Named flow routes and other features in Park Wood. Symbols indicate locations of proposed and installed leaky dams and water level monitoring devices (FreeStation and gauge) comprising: leaky dams (purple circles) and tree trunk dams (blue squares) constructed as part of the DEFRA funded project, pre existing leaky dams (red circles), FreeStations (Crossed circles) and Hillingdon Council's flow gauge (plus symbol).

Suitable sites for leaky dams were identified through consultation/catchment walkovers in conjunction with the local NRFLAG group, RWMAG members, and the London Borough of Hillingdon. Observations from local residents and Hillingdon Council officers regarding the flow of water through the catchment during rainfall events helped to validate surface water flood mapping and select the channels within which to site dams. The main flow paths were given reference names to improve decision making and help locate structures (Figure 3).

Channel names correspond to those in Figure 3.

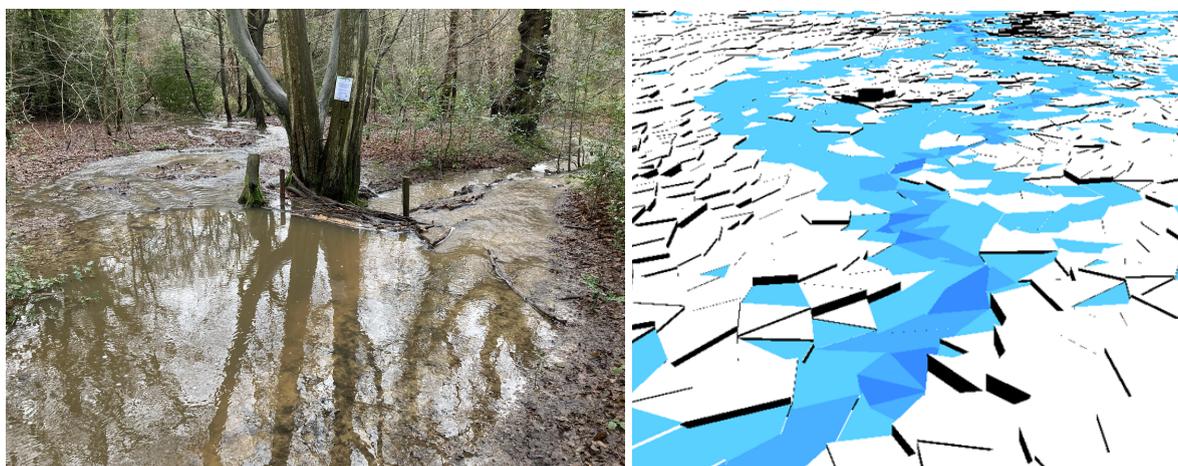
**Figure 5:** Field observations and model results for January 2021 event in approximately similar location (N.B. photograph not taken at event peak)

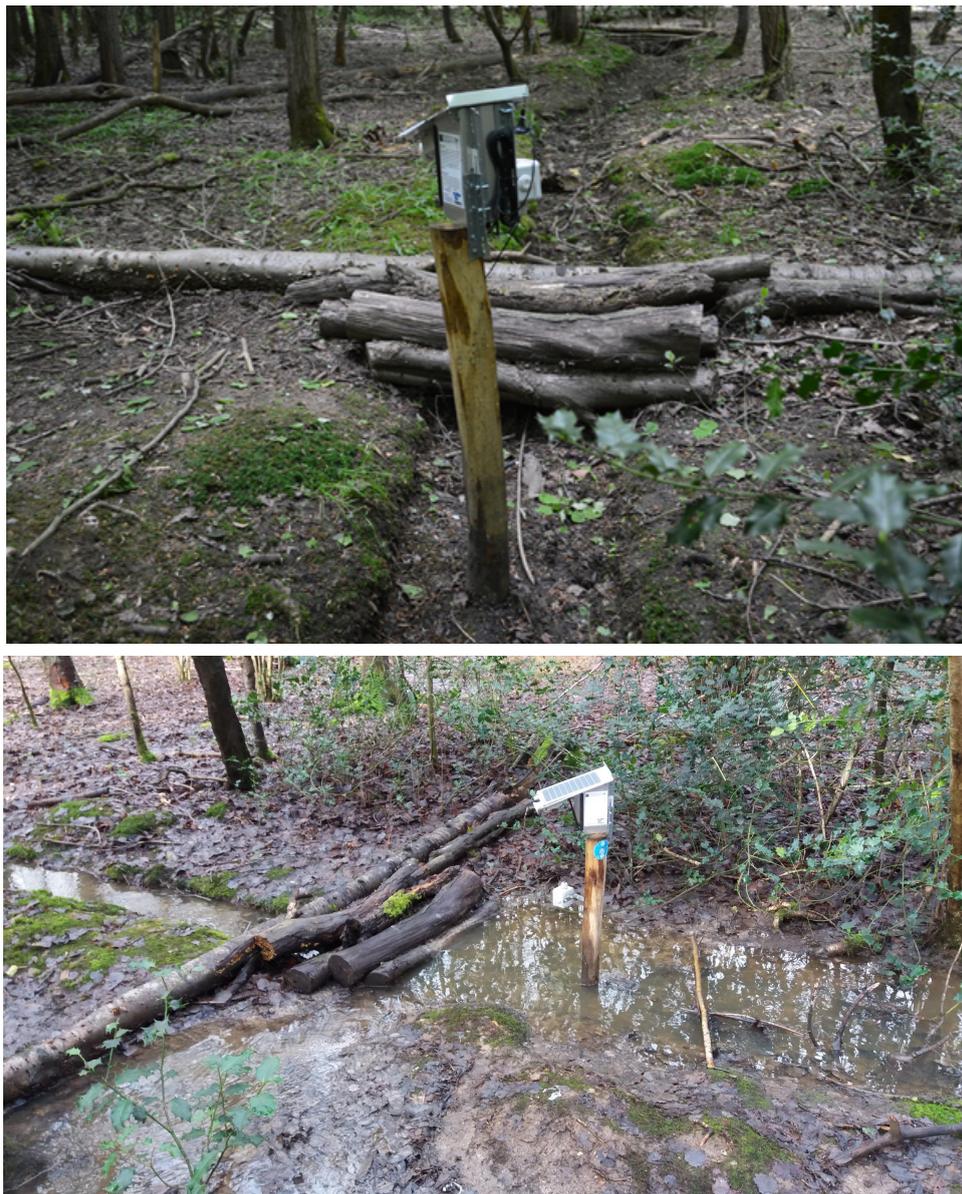
**Figure 8:** FreeStations deployed up and downstream of leaky dams in Park Wood.

Four sensors were deployed on the main channel as pairs up and downstream of two series of leaky dams (Figures 3 and 8). The fifth was deployed on a different ephemeral channel to assess the contribution of its catchment to flows through the lower part of the wood. Other channels of other ephemeral tributaries were undefined and shallow therefore less likely to record changes in water height.

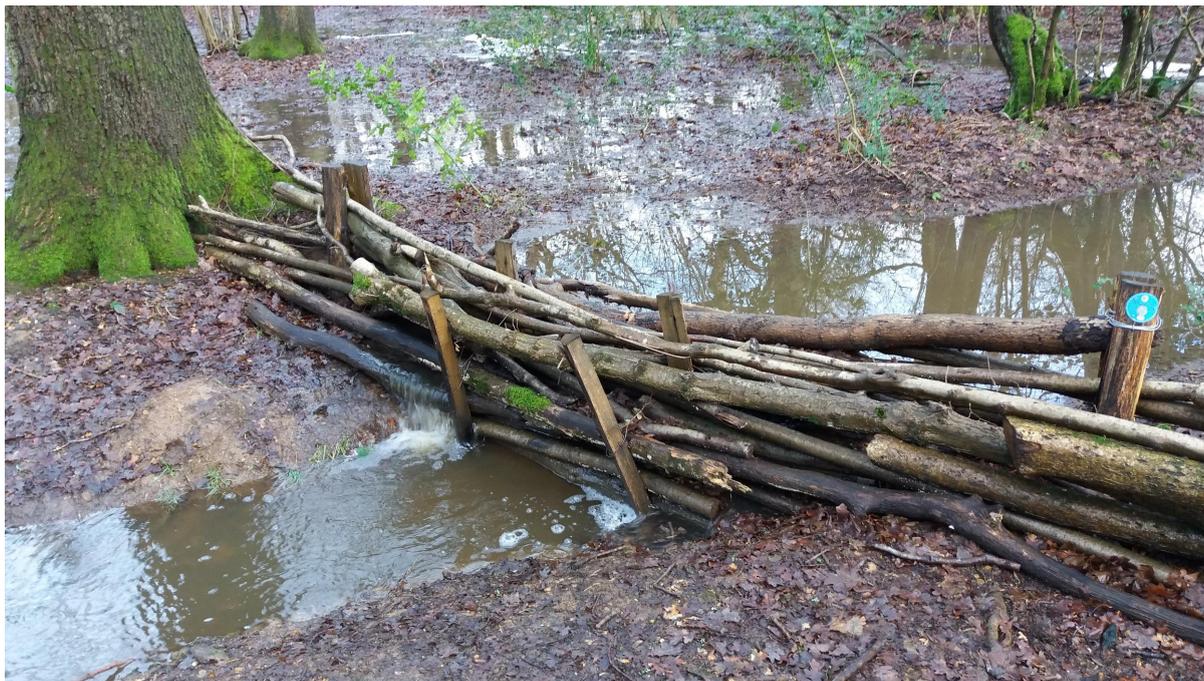
*Figure 10: QR codes (blue disc at right) deployed on leaky dams in Park Wood.*

After construction of the majority of dams, QR codes were installed on or near selected dams in Park Wood (Figure 10) to further encourage woodland users and local residents to engage with the project and as part of project legacy. Scanning the QR code connects users to Thames21's project web page containing information about NFM for flood risk mitigation, project volunteering opportunities and links for reporting dam state of repair and functioning.

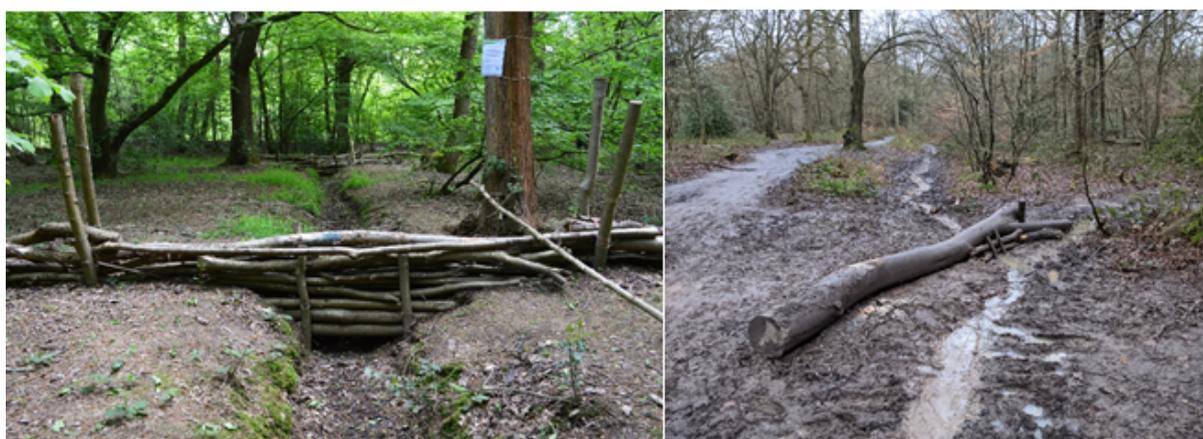
**Figure 11:** Examples of leaky dams (left) and tree trunk dams (right) installed in Park Wood. The tree trunk dam in this example was intended to divert flow off the footpath to infiltrate in the wood. Note the notice beside the dam containing information about NFM and the project to deter vandalism of structures.

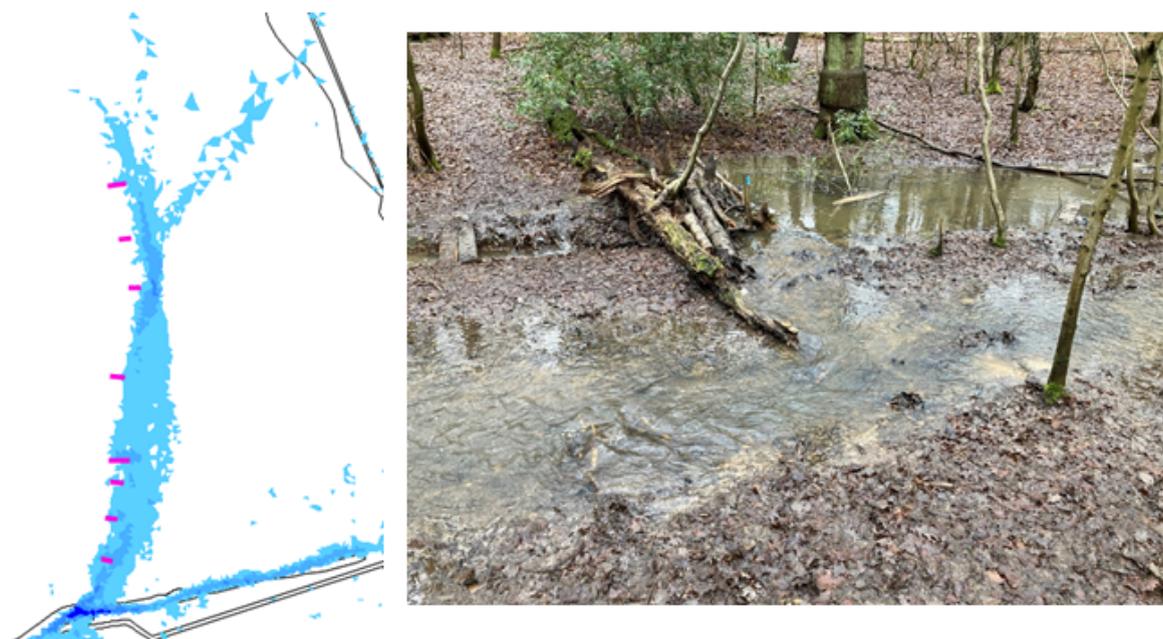
**Figure 13:** Results of hydrological modelling that indicate flow routes extend wider than and current leaky dams, indicating dams should be widened to intercept more flow (left); corroborated by photos taken in the wood during flow events (right).

An example is shown in Figure 13 where the approximate location of the dams (in pink) are occasionally bypassed by the main flow path. In these areas, longer dams are recommended so that the whole flow path is intercepted.

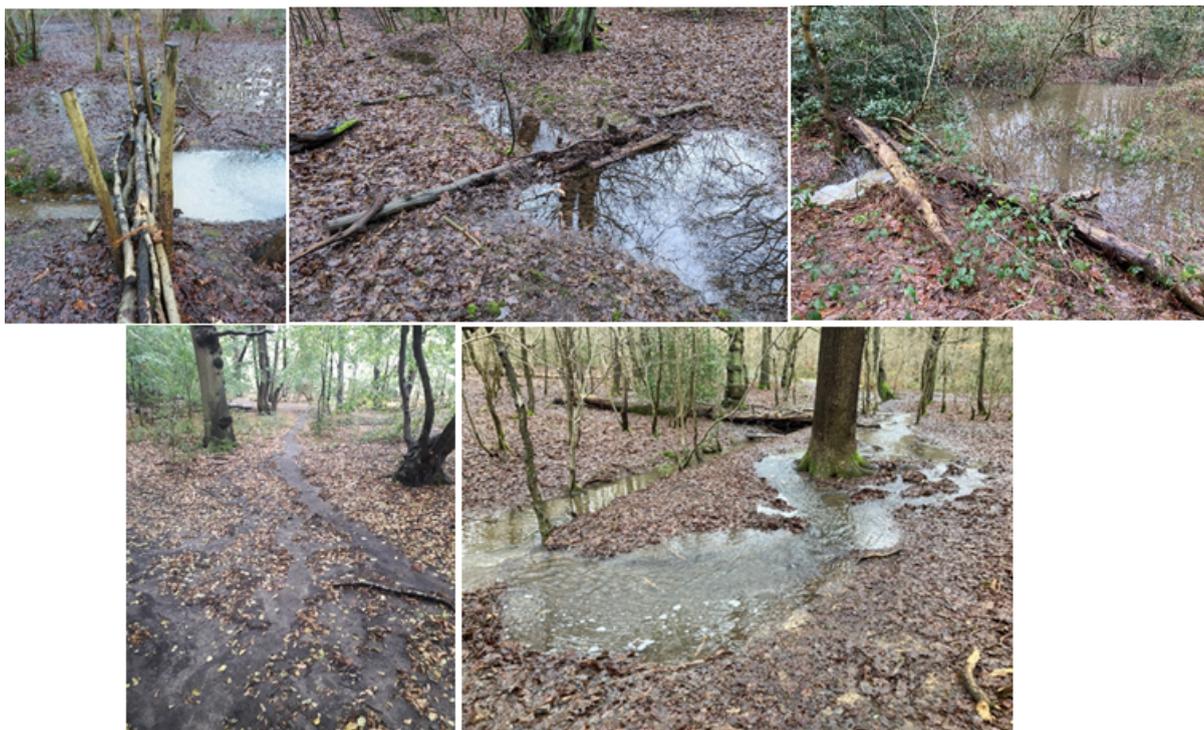
**Figure 17:** Examples of flow attenuation by leaky dams (above) and out of channel flow paths (below) in Park Wood

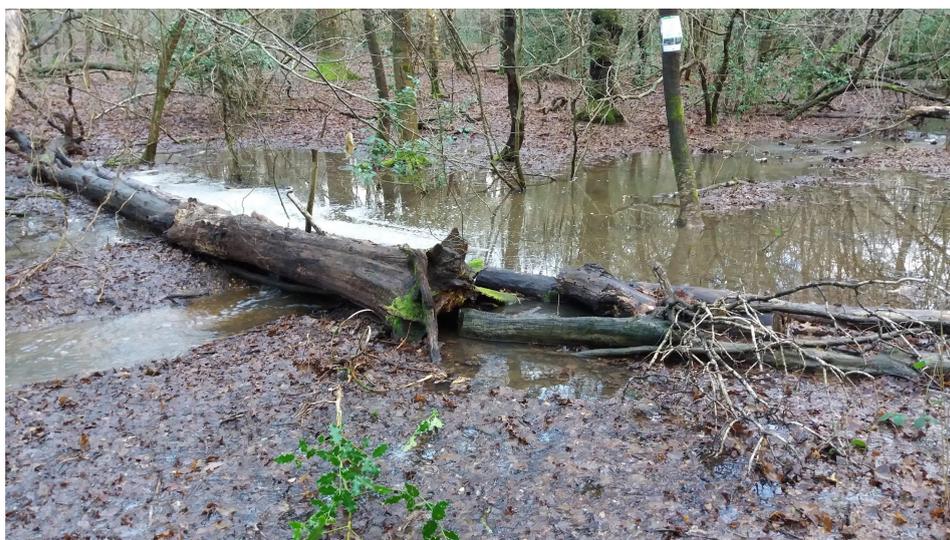
**Figure 20:** Total local hourly rainfall (mm, blue) and 15 minute resolution water level (cm, red) for a rainfall event on 28th January 2021 recorded by the gauging station on the perimeter of Park Wood (above), combined with photographic evidence of dam performance (below).

The local hydrometry provides context to the photographic and manual observations during flood events. The green line in Figure 20 shows the time at which corresponding photographic observations of the leaky dams storing water following a rainfall event were taken.

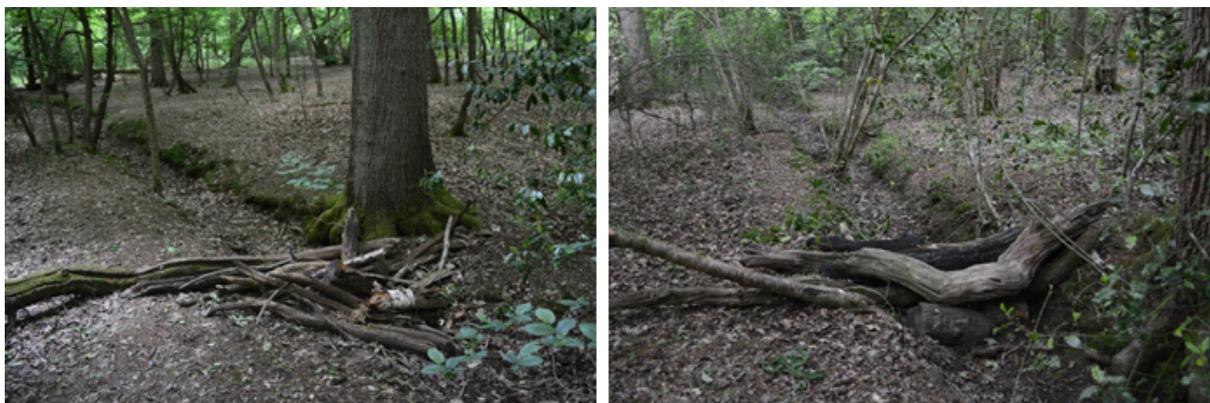
*Figure 23: Examples of informal dams in Park Wood*

- i) Vandalism and complete destruction of dams - including incidence of dam timbers being set fire to.
- ii) Alteration of formal dams by adding or removing timbers.
- iii) Moving of large logs intended to divert flow out of channel into the woodland.
- iv) Building informal dams across channels, not necessarily in ideal/permitted locations for holding water. Some informal structures were robust and moderately enduring and potentially contribute to holding back water and sediment and wetting the local woodland; others are more ephemeral with risk of creating debris blockages upon breakdown (Figure 23).

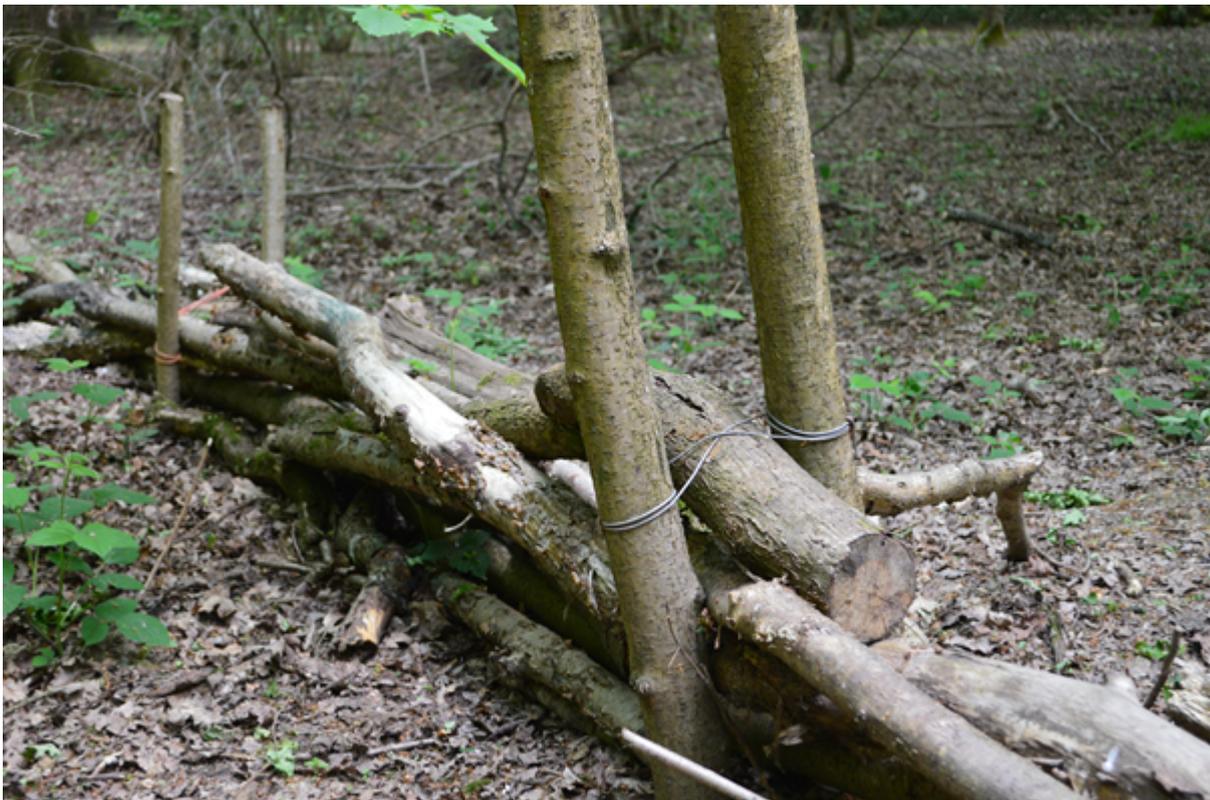
**Figure 24:** *Wiring as a measure to deter vandalism and timber removal of leaky dams.*

Vandalism risk contributed to learning in dam construction. Dams built early in the project strived to maintain a fully natural appearance. However, attributes common to all dams vandalised later in the project included i) lack of wiring or angled posts to prevent removal of horizontal timbers and ii) no substantial posts on the downstream side. On small, ephemeral channels in public places, learning indicates that dams need to look formal and include anti-tamper measures Figure 24.
