RECLAIM OUR RIVERS: WALLINGFORD BEACH

Citizen Science Water Quality Sampling Report 2023

Prepared by Aggie Hodges, Thames21, reviewed by colleagues at Thames21

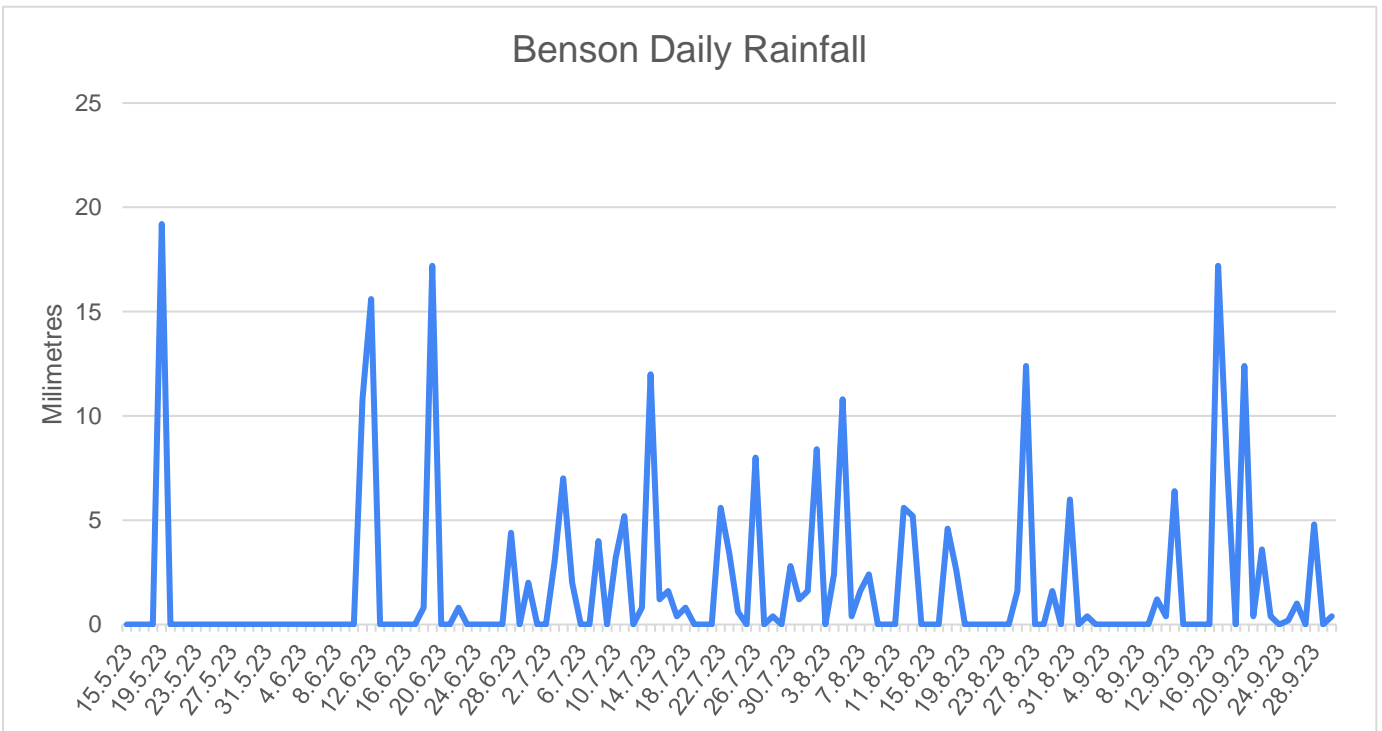
Figure 2 - Daily rainfall at Benson rainfall monitor

The highest rainfall recorded this bathing season at Benson rainfall monitor was on 19.05.23 at 19.2mm. The month with the highest total rainfall recorded at Benson was August, with total rainfall at 67.2mm and a daily average of 2.2mm (Table 5).

As table 6 depicts, rainfall events of varying precipitation levels occurred shortly before or during sampling on 14 out of 20 dates. Figures 2 and 3 demonstrate how these rainfall events regularly correlate to spikes in FIO levels, such as after heavy rainfall (17.2mm) on 19.06.23 and in the 72hrs preceding sampling on 20.09.23 (24.8mm). On this sample date, river levels at Benson Lock were 0.09m higher (0.24m) than the average levels (0.15m) recorded during the 2023 bathing water season (River Levels N.D).

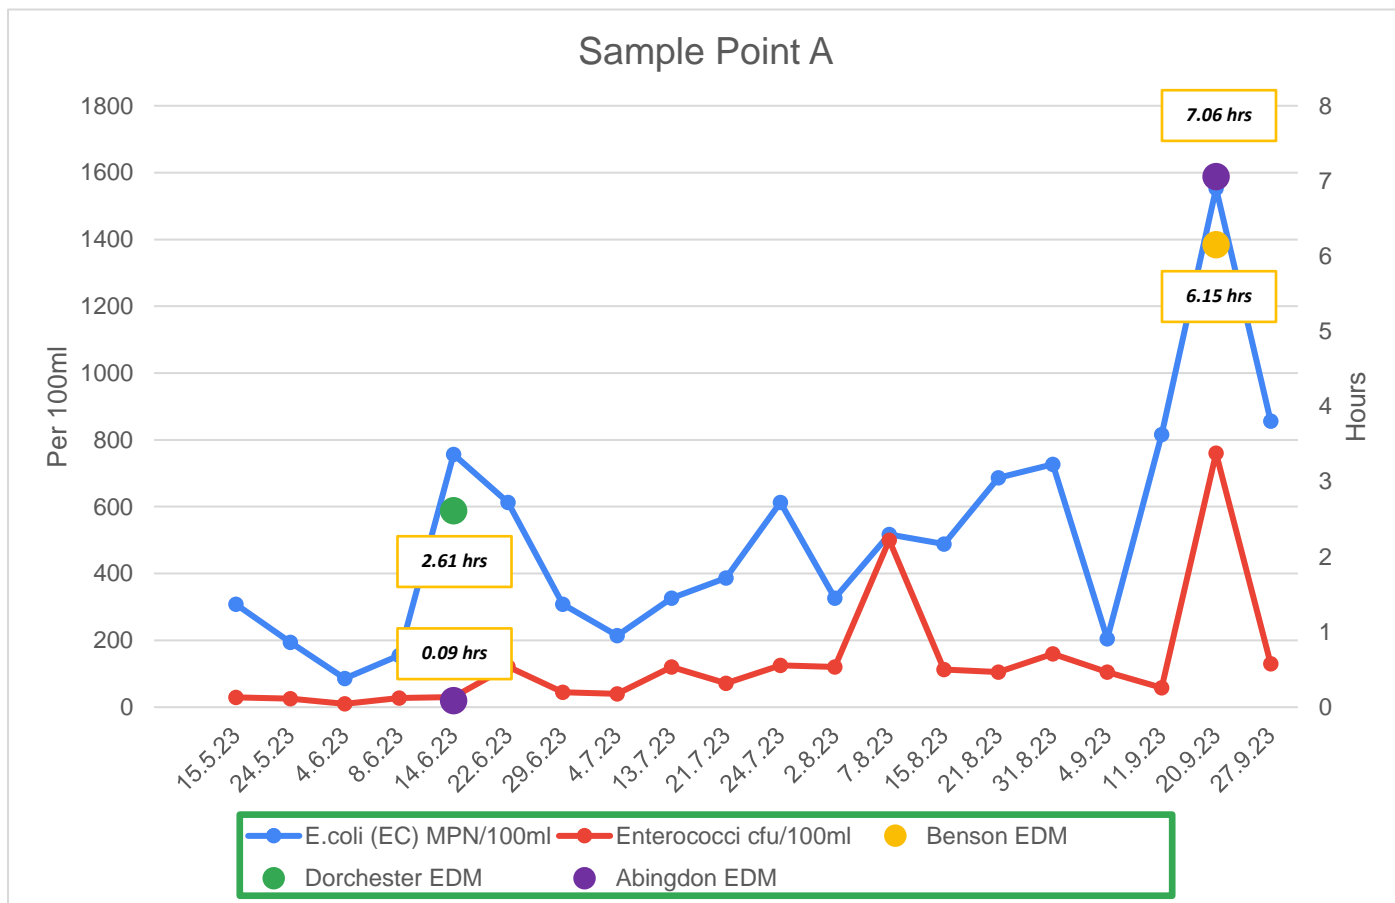
Figure 4- FIO levels with spill correlations

EDM spills at Benson, Dorchester and Abingdon sewage treatment works (STW) appeared to correlate to the heavy rainfall dates mentioned above, with the exception of the heavy rain seen on 19th May which did not appear to trigger any EDM spills.

The sharp increases in FIO results at Wallingford Beach in June and September show the hallmarks of point source impacts that are possibly from upstream sewage treatment works, heavily affecting water quality. Interestingly, EDM data shows no discharges occurring in the 72 hours before sampling took place on 20.09.23. It does, however, show Abingdon and Benson STW's discharging just a few hours after samples were taken on this date, on which sharp increases in EC and IE were seen. Further investigations into upstream infrastructure, including evidence on the quality of treated effluent, are needed to identify the source of inputs for these sharp increases and to determine the measures needed to mitigate them.
