# Lower Roding Water Quality Dry Weather Report 2025

The Lower Roding Water Quality project is a collaboration between Thames21, the River Roding Trust, and Thames Water

Prepared by Aggie Hodges & Jack Beard, Thames21 & Paul Powlesland,  
River Roding Trust

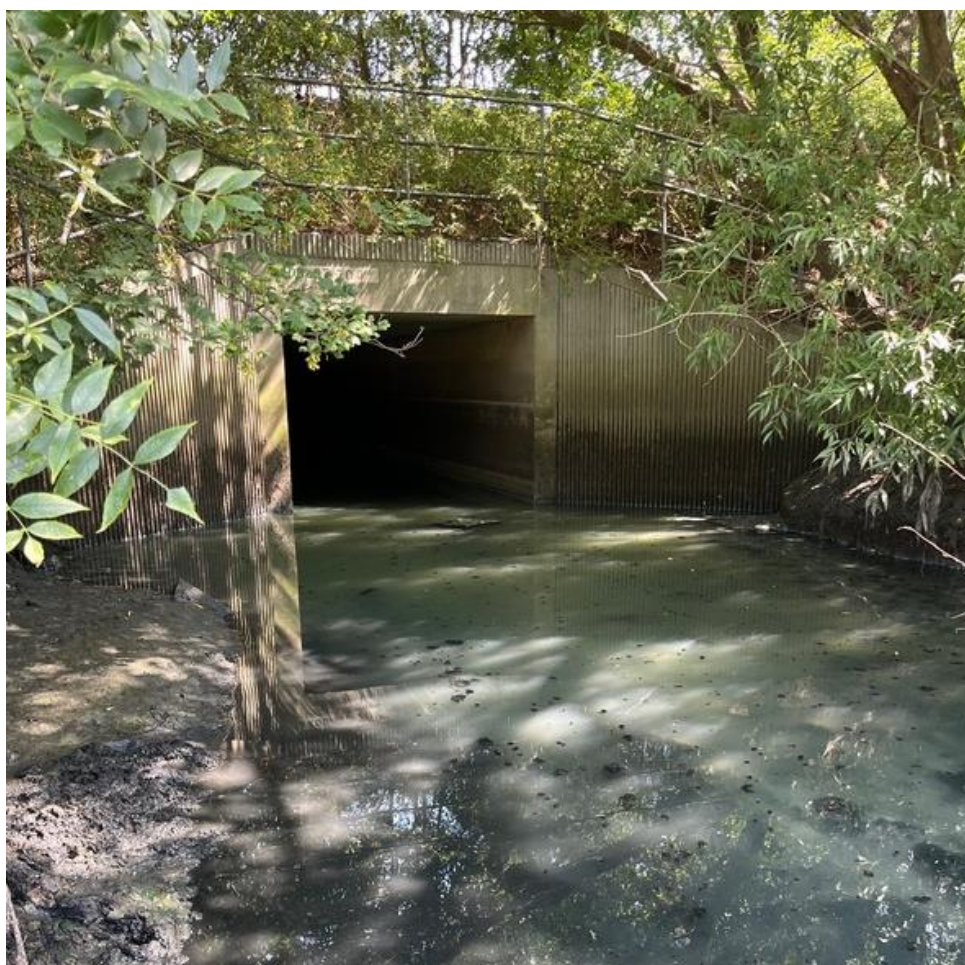
*Figure 1: One of the only open air sections of the Cranbrook, close to the confluence showing visual evidence of pollution*

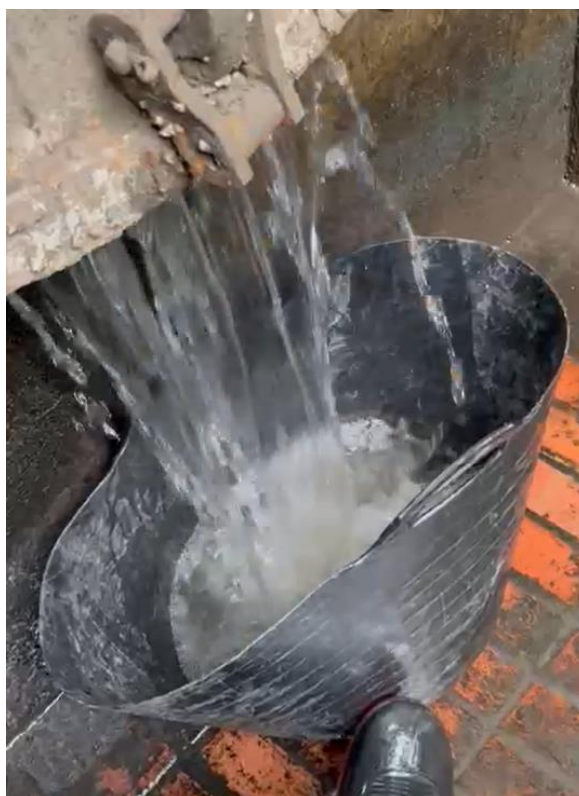
To estimate flow a container of known volume was held beneath each outfall and the time taken to fill it was recorded using a stopwatch (see **Figure 3**). Flow rate was then calculated as litres per minute by dividing the container volume by the fill time. This method is well-suited to citizen science monitoring programmes. While it is subject to some variability depending on outfall accessibility and form of discharge, it provides a practical basis for comparing relative flow rates across sites – and when combined with ammonia concentration data, enables the calculation of ammonia loading estimates for the prioritisation of outfalls in this report.

*Figure 3: Still from a video of the flow measurement methodology using a bucket at the outfall.*

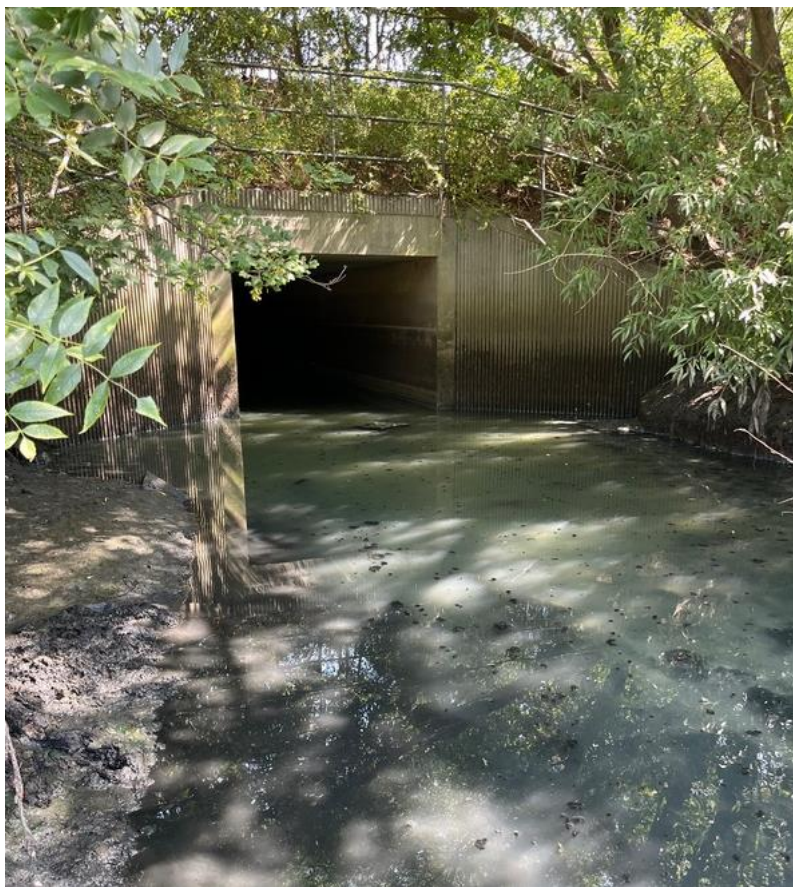
*Figure 11: One of the only open air sections of the Cranbrook, close to the confluence showing visual evidence of pollution*

| Organisation / Timeframe | Detail |
|---|---|
| Short-term solutions | <ul style="list-style-type: none"> <li>• Misconnections resolved as a priority. Monitoring undertaken following this to determine if any further asset failures remain.</li> <li>• At least 1 treatment wetland constructed by the end of 2026. Ideally 2 constructed; one at Aldborough Hatch &amp; one at Valentine’s Park.</li> </ul> |

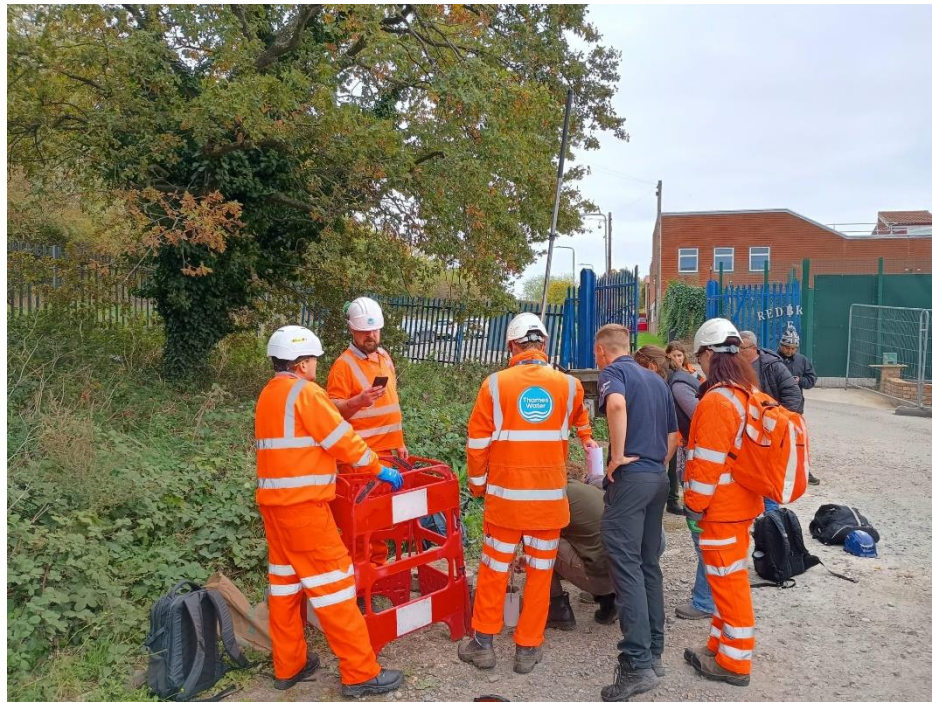
Figure 14: Sampling undertaken by Thames Water, Thames21, River Roding Trust, the Environment Agency & Seneye Sensors in October 2025

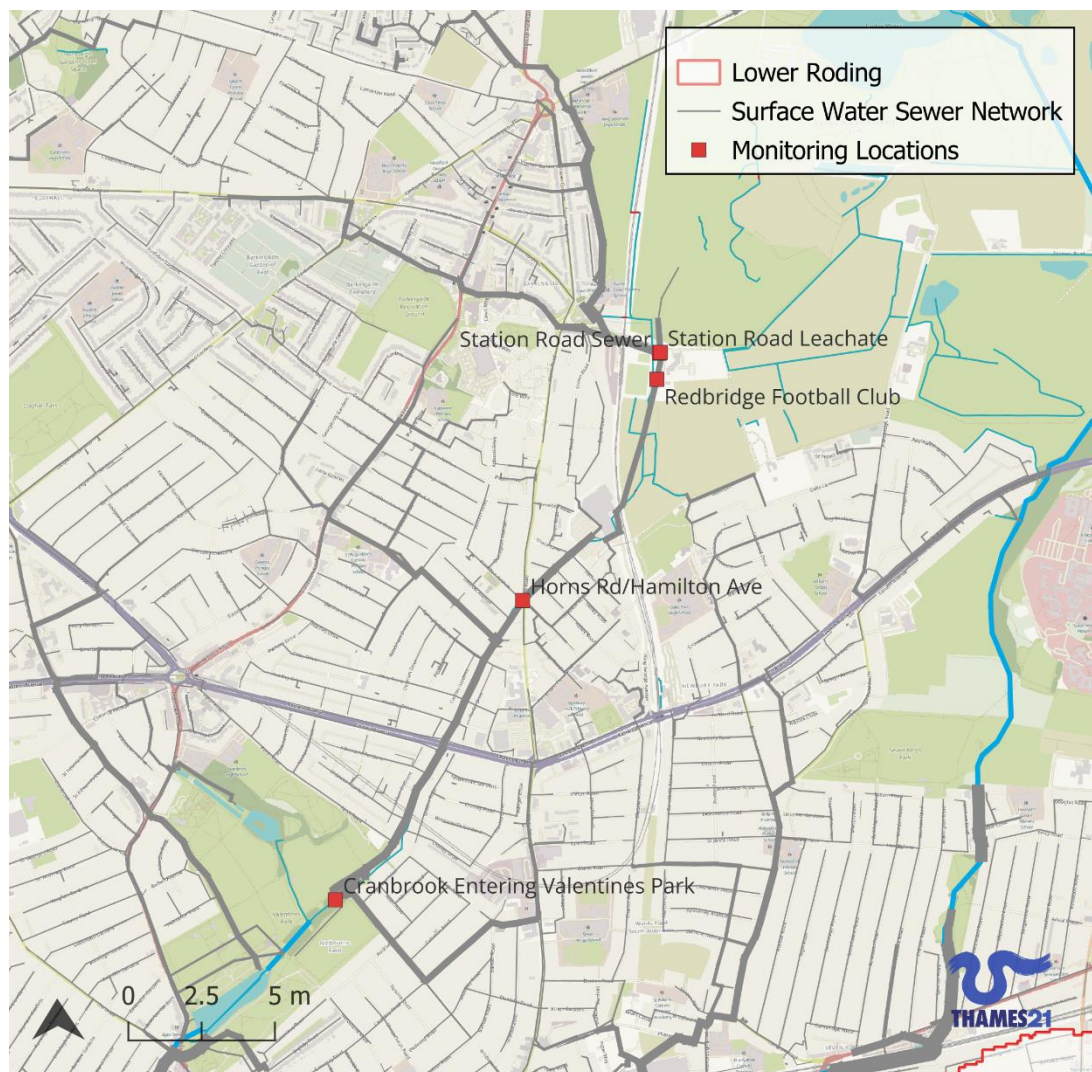
Figure 154: Sampling undertaken by Thames Water, Thames21, River Roding Trust, the Environment Agency & Seneye Sensors in October 2025

Elevated levels of both ammonia and E. coli were found between the confluence and upstream to Station Rd, indicating human faecal contamination to be a major source of pollution affecting the entire Cranbrook tributary.

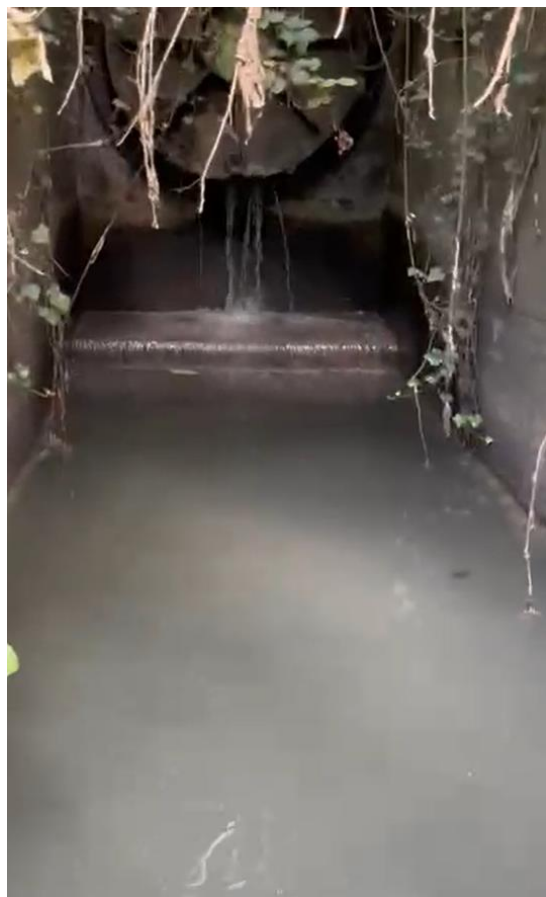
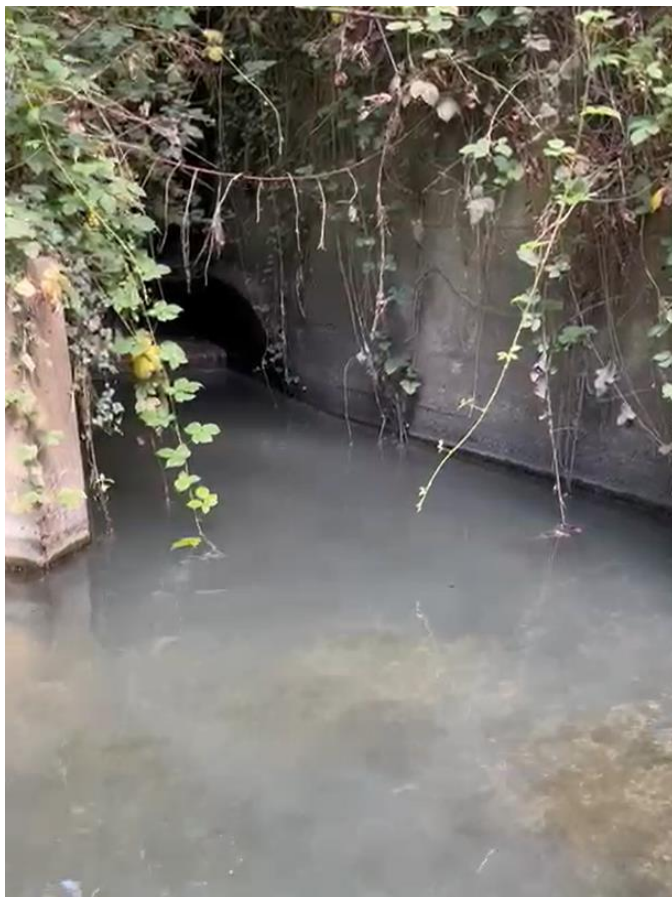
There is a clear visual impact on the river, although this dissipates reasonably quickly and the ecological impact is nowhere near as large as the Cranbrook confluence.

*Figure 17: Stills from video evidence showing cloudy water at Royston Gardens outfall*

This outfall has previously been identified as problematic, and Thames Water has begun investigations into asset failure and misconnections. A significant opportunity is apparent here for the delivery of Nature-based Solutions at Royston Gardens, with large parts of land currently lying unused – this could potentially be a good site to de-culvert the surface water line and pass it through a constructed wetland system to reduce the sewage and road runoff pollution entering the Roding. Resources should be placed into further scoping this opportunity.

| Organisation / Timeframe | Detail |
|---|---|
| Short-term solutions | <ul style="list-style-type: none"> <li>• Misconnections resolved as a priority. Monitoring undertaken following this to determine if any further asset failures remain.</li> </ul> |

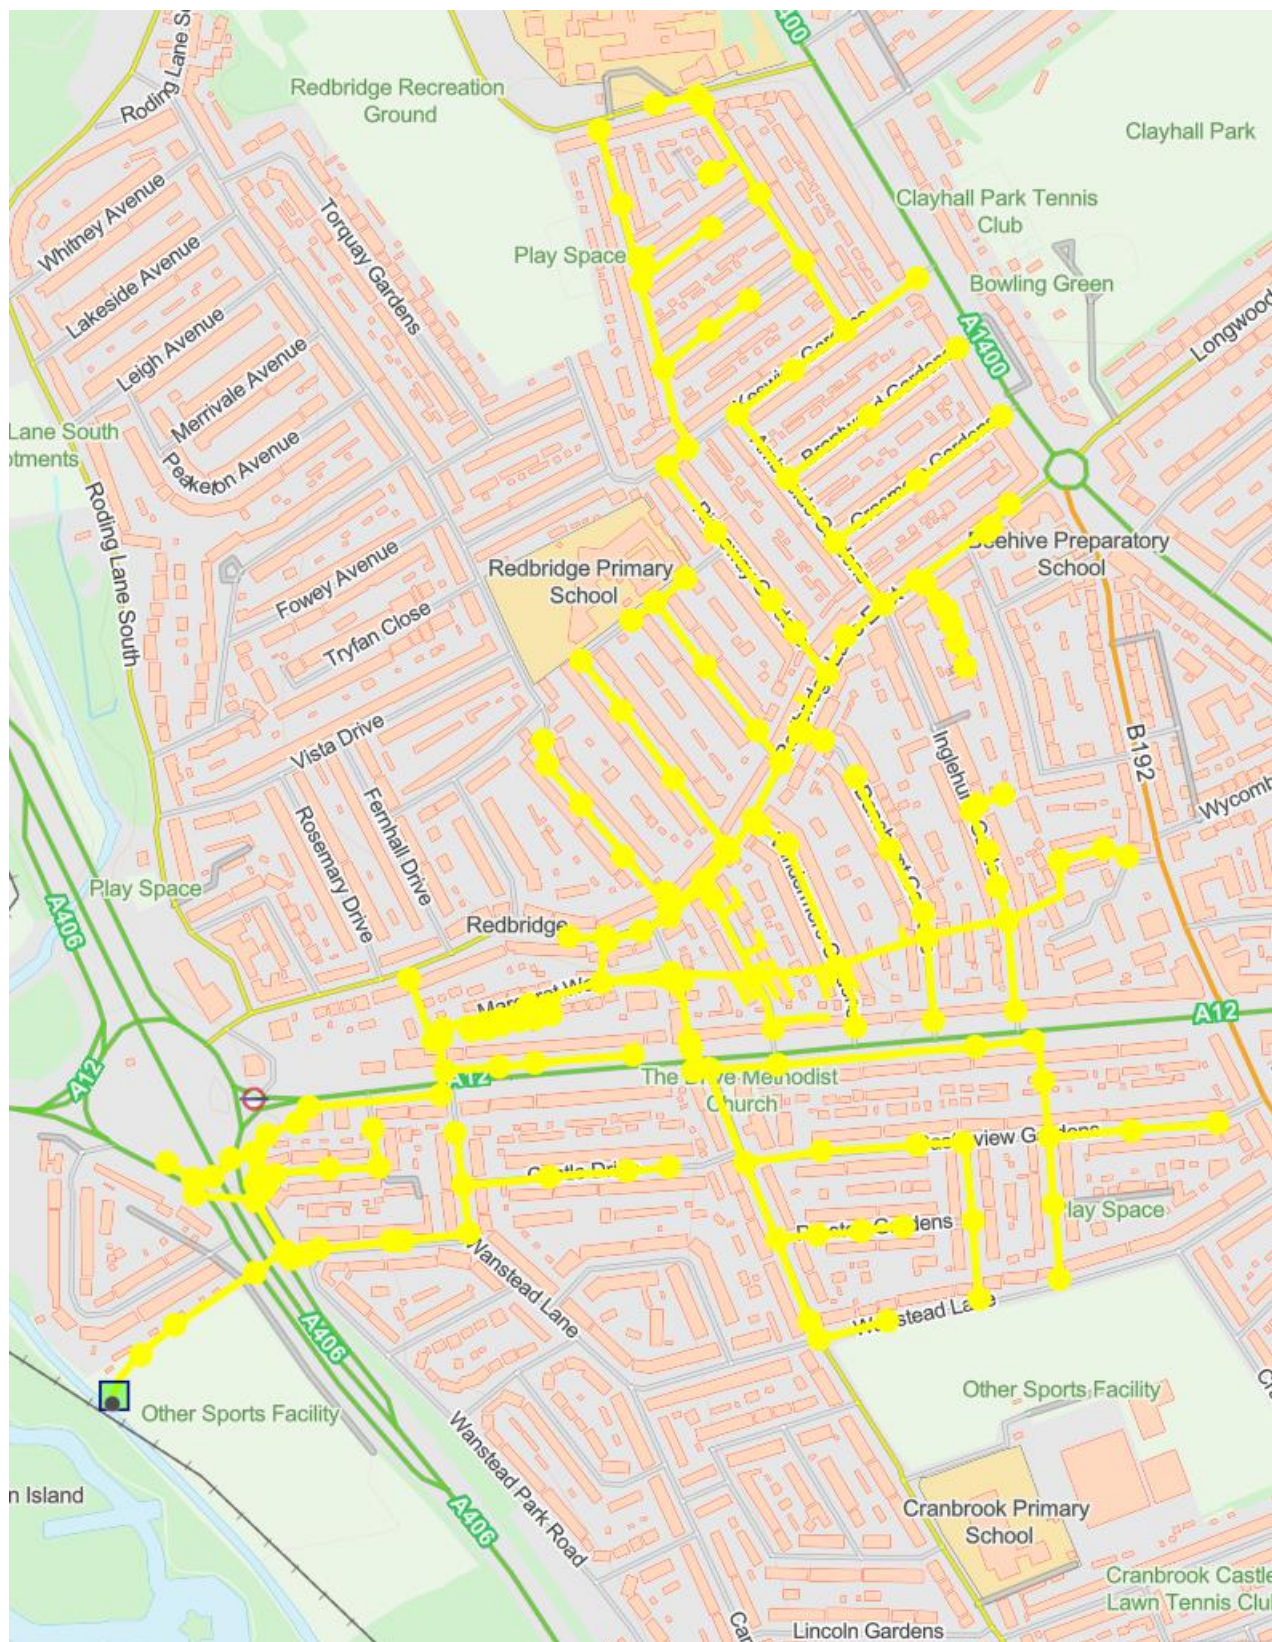
Figure 18: Surface water catchment of the Royston Gardens Outfall prepared by Thames Water. Yellow lines are indicative of the surface water drains that contribute to the eventual outfall, which is represented as a green square.

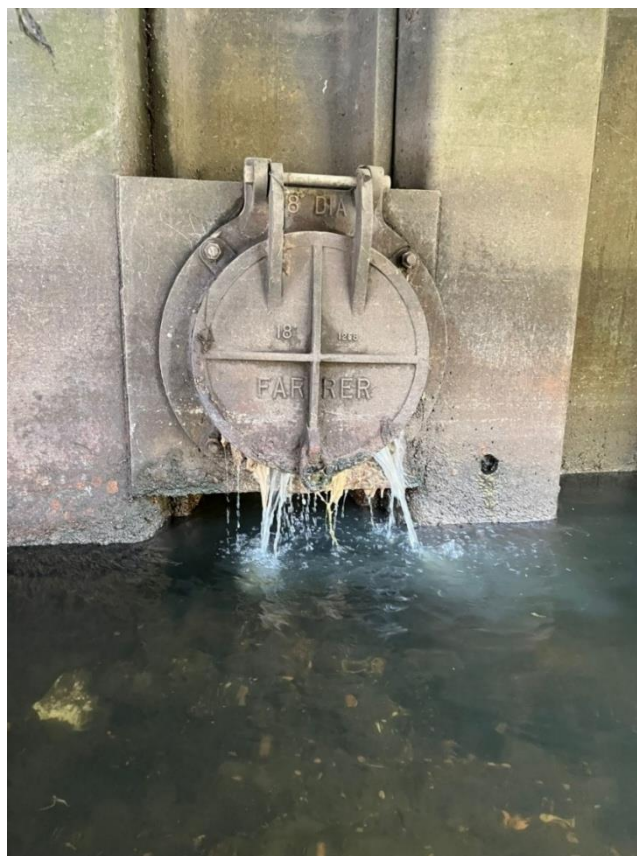
This outfall has both high ammonia levels and a pronounced visual impact on the river. The water is cloudy downstream of the outfall and there is usually visible faeces and toilet paper. This suggests that any misconnection or fault causing the sewage to enter the river is close to the outfall, as it has not had much time to break down.

Figure 21: outfall at Aldersbrook showing evidence of sewage pollution

Despite the extremely high concentrations, the relatively low average flow of 1 l/s means the total loading is lower than the Cranbrook, Royston Gardens, and Roding Lane South. However, the presence of visible faeces and toilet paper at the outfall on multiple occasions strongly suggests a very local misconnection or asset failure close to the discharge point.

Collaboration should be maintained to ensure that action is taken to fix asset failure and misconnections which are currently discharging sewage via this outfall.

| Organisation / Timeframe | Detail |
|---|---|
| Short-term solutions | <ul style="list-style-type: none"> <li>Misconnections resolved as a priority. Monitoring undertaken following this to determine if any further failures remain.</li> </ul> |

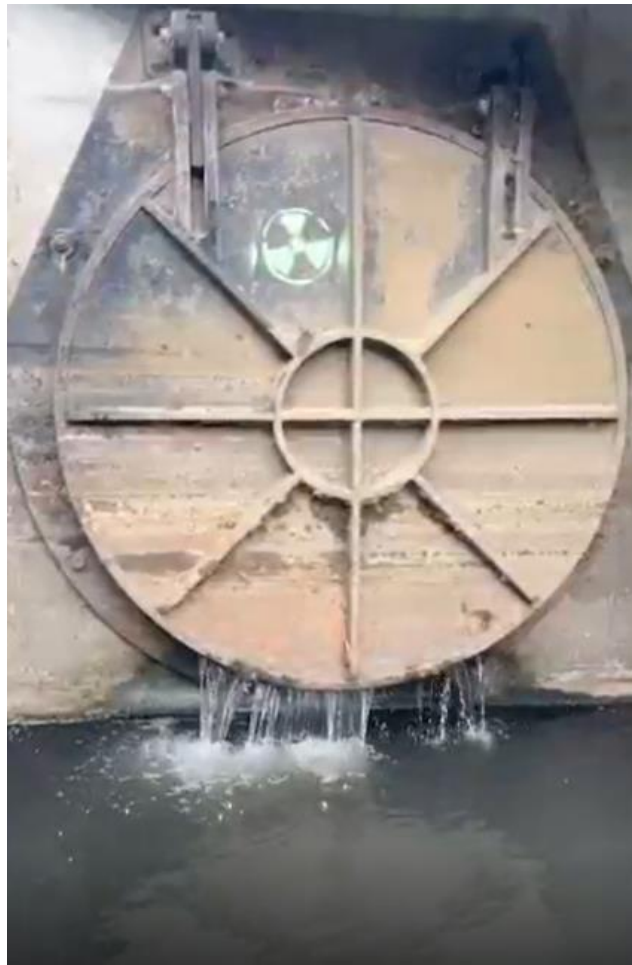
Roding Lane Substation is an interesting outfall, given that it doesn't have much visual impact on the river but is a significant source of sewage pollution. This is because this outfall is likely an tributary which has been culverted (see Annex B) with significant flows even in dry weather. This dilutes the ammonia values to below many of the other outfalls outlined in this report. However, the high volume of the outfall means that the sewage loading and thus impact on the Roding is of concern.

*Figure 23: Outfall at Roding Lane South Substation*

This outfall was recently added to TW's Surface Water Outfall Programme list, with ten properties identified as misconnected. It is imperative that these properties' misconnections are resolved swiftly, and that monitoring remains following these remediations to ensure no other inputs are affecting ammonia levels at this outfall. Continued collaboration across partners should focus on monitoring the effects of proposed actions arising from this and continuously checking that asset failures or misconnections are contributing further pollution to the Roding.

| Organisation / Timeframe | Detail |
|---|---|
| Short-term solutions | <ul style="list-style-type: none"> <li>• Misconnections resolved as a priority. Monitoring undertaken following this to determine if any further asset failures remain.</li> </ul> |

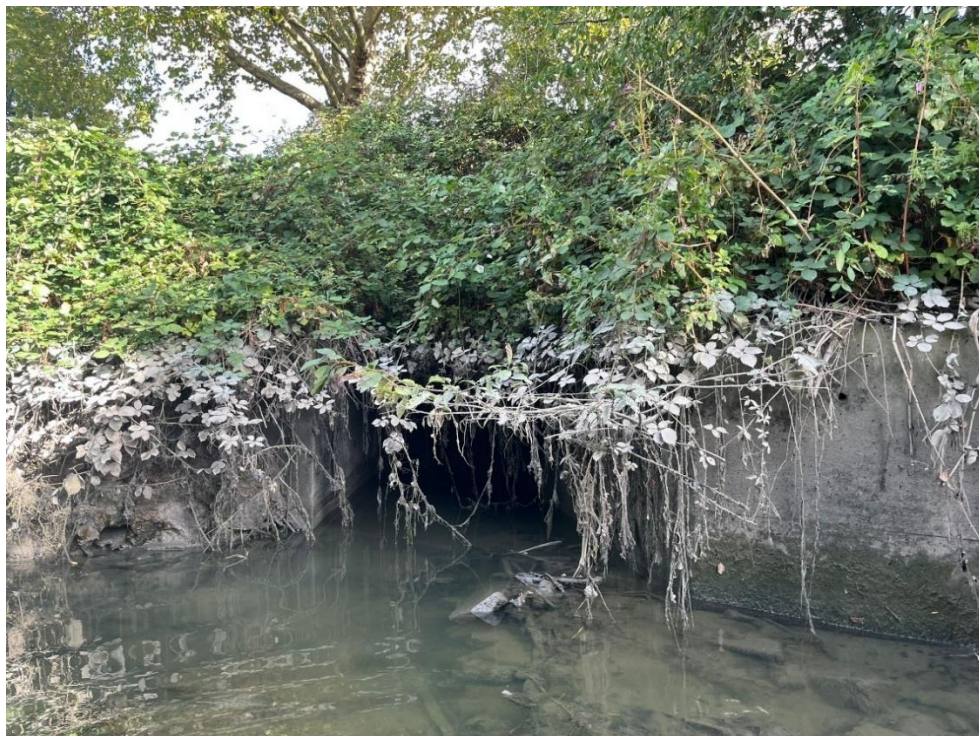
Uphall Rec outfall is a surface water outfall covered by a flap valve that discharges straight into the Roding (see **Figure 26**). Given that the outfall was flowing all the times of sampling (even in dry weather), it is likely to be a covered tributary that has been contaminated with sewage, or pure sewage contamination. This outfall consistently has a visible impact on the river, and is often augmented with visible solids, rag and cooking fat.

Figure 26: Cloudy water at Uphall Rec outfall.

| Organisation / Timeframe | Detail |
|---|---|
| Thames Water | <ul style="list-style-type: none"> <li>SWOP investigations for the Aldersbrook, Uphall Rec and Ilford Hill Bridge outfalls should be conducted as a single programme of work.</li> <li>Any faulty assets leading to sewage release via this outfall to be repaired.</li> </ul> |
| Short-term solutions | <ul style="list-style-type: none"> <li>Misconnections resolved as a priority. Monitoring undertaken following this to determine if any further asset failures remain.</li> </ul> |

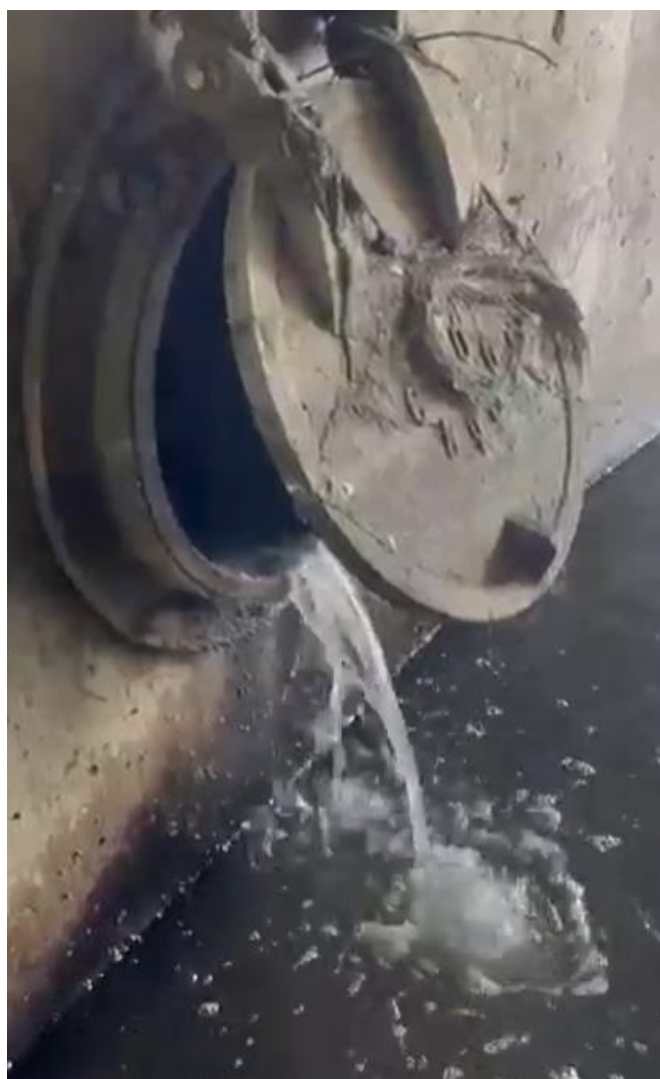
The discharge at Ilford Hill Bridge appears reasonably clear, with little visual impact on the river. However, the outfall has reasonably high ammonia levels, which, combined with the constant flows gives it a sufficiently high loading on the river to warrant concern. This is especially so given its location near three other significant outfalls, which mean that the stretch of the river into which it discharges is the most impacted by sewage on the whole river. Prior to this monitoring programme, this outfall was not on Thames Water's SWOP list, but has now been added.

Figure 29: Still from a video of discharge from the outfall at Ilford Hill Bridge.

| Organisation / Timeframe | Detail |
|---|---|
| Thames Water | <ul style="list-style-type: none"> <li>SWOP investigations for the Aldersbrook, Uphall Rec and Ilford Hill Bridge outfalls should be conducted as a single programme of work.</li> <li>Any faulty assets leading to sewage release via this outfall to be repaired.</li> </ul> |
| Short-term solutions | <ul style="list-style-type: none"> <li>Misconnections resolved as a priority. Monitoring undertaken following this to determine if any further failures remain.</li> </ul> |

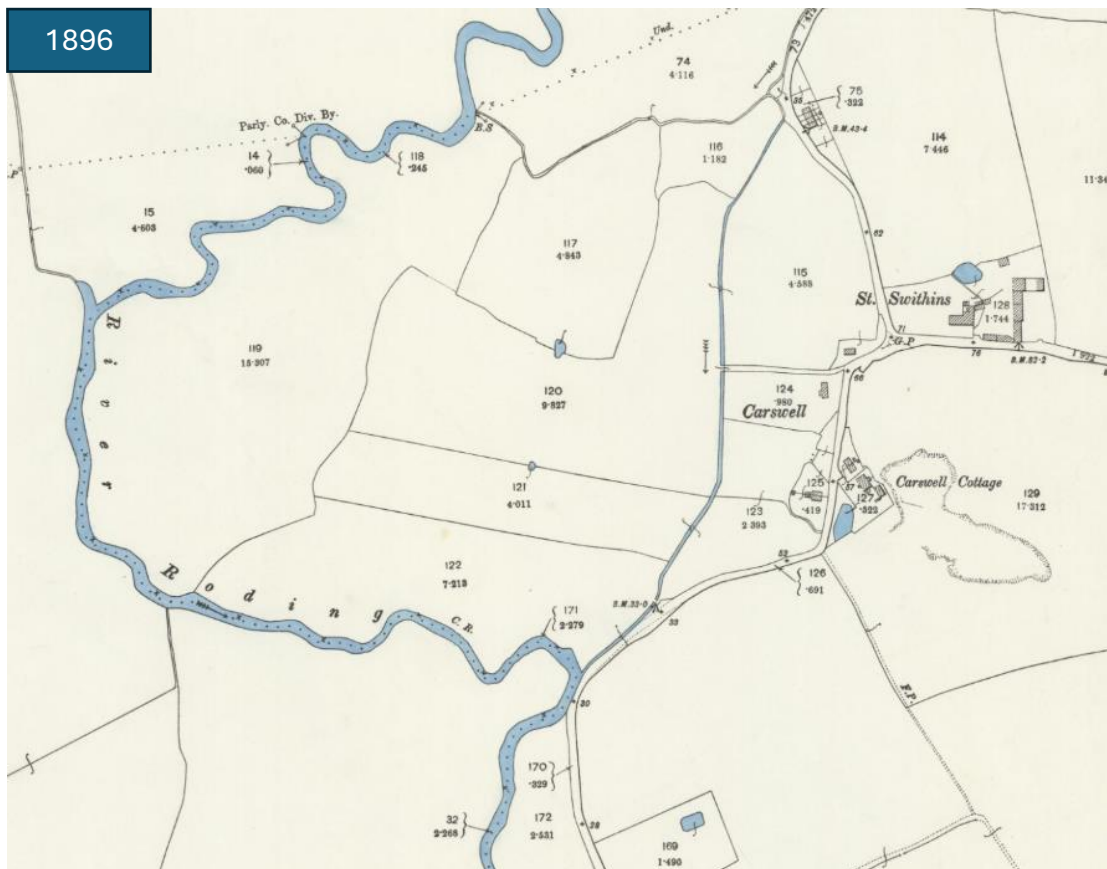
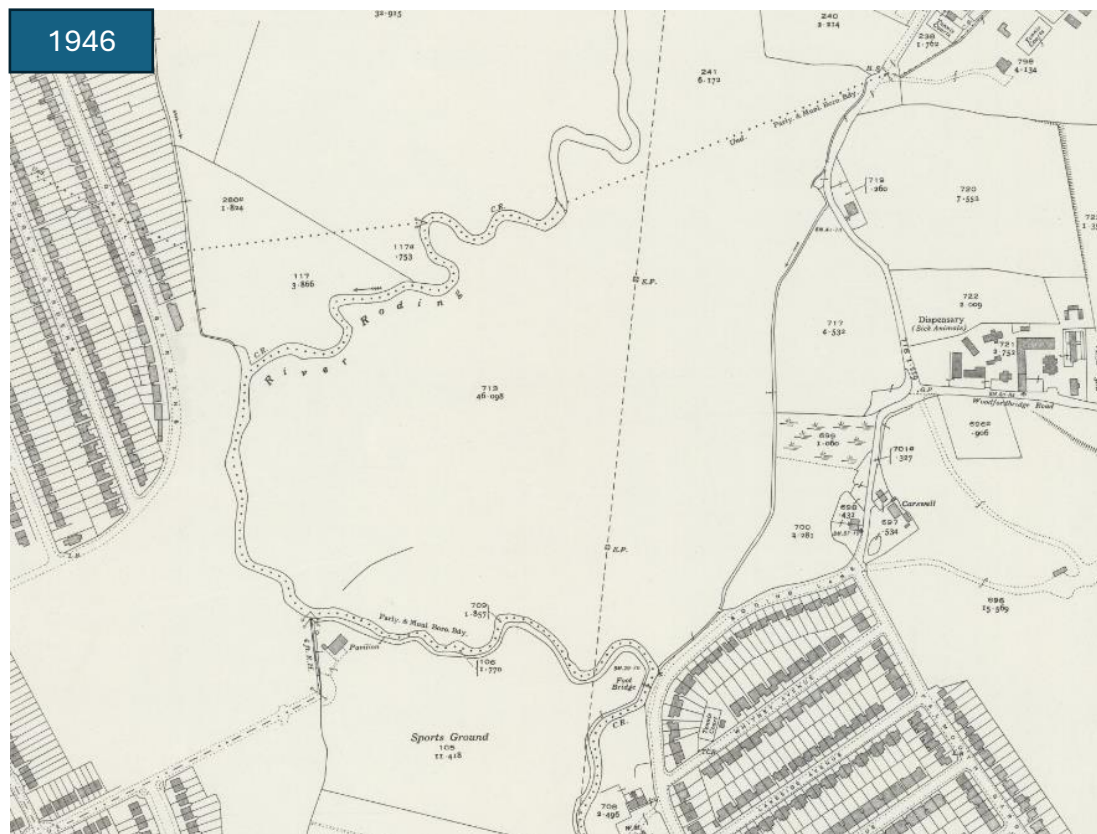
## Roding Lane South

The following maps support the theory that the Roding Lane South outfall is in fact a covered tributary. This tributary (or drainage ditch) is shown joining the main Roding from the East in these pictures. In the last of these this is shown as an embanked channel sitting higher than the marsh area on the inside of the meander. This shows that the channel was diverted in the 1960s, so it must have been further diverted to the North and culverted sometime in the decades that followed.

The stub of the old tributary channel is still present and has been identified by the River Roding Trust as a potential future restoration site.
