River Ravensbourne, Ladywell Fields, Lewisham

The story so far

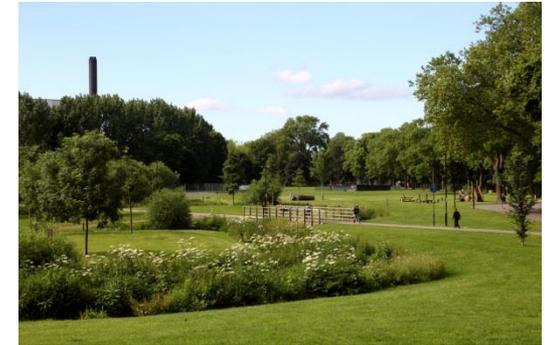
AFTER – vegetation lines the river as it meanders through the park fields ©Bill Green Photography

The river ran through a concrete channel in a dark, unloved corner of the park. Low light levels made the site unpopular with locals and limited the number of species which could live within and beside the water. This restoration project liberated the river from its old channel by meandering it back through the centre of the park; giving it more room to safely store flood water during rainy spells and creating more habitats for wildlife, including kingfishers and herons.

- Providing a broader range of habitat by varying the riverbed depth with a new gravel-bed
- Removing railings and creating new access points to the river
- Creating small side channels called backwaters for fish to rest in
- Creating river terraces and meanders
- Installing new footpaths and improving park entrances

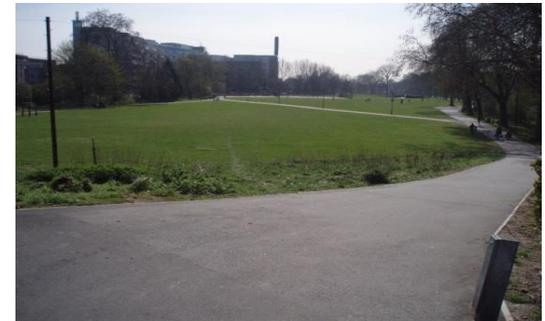
BEFORE – The River Ravensbourne was entirely hidden from view prior to the restoration effort © Lewisham Council
